Ray's caravan Repair

ABI Marauder 520 ET

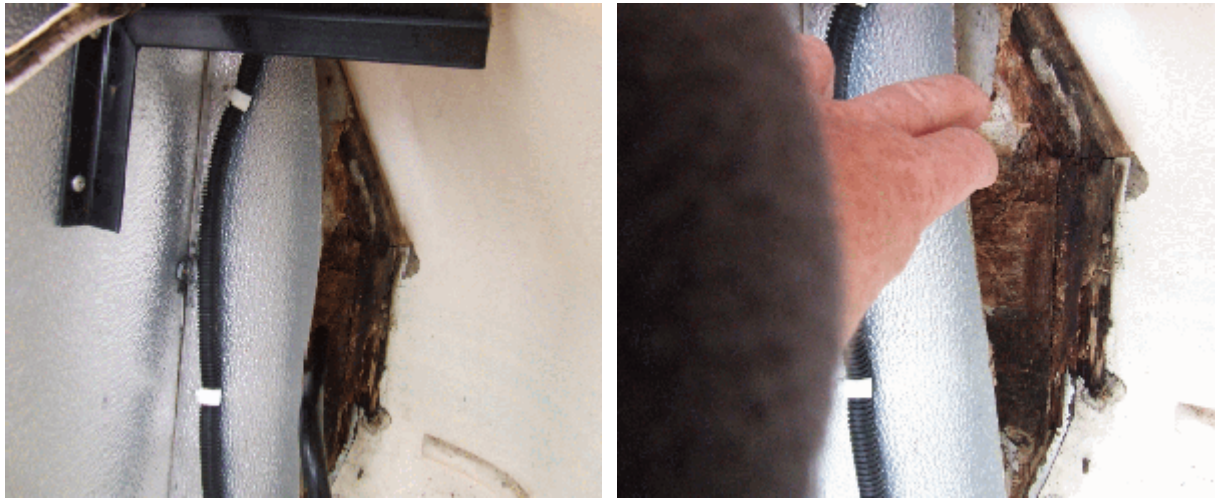
I was rummaging around inside the front external locker when I first spotted the signs; crumbs of rotted wood beneath the front down spar. Closer inspection revealed a not insignificant missing section of wood beneath the aluminium sheet that covered it. The edges of the wood I could feel were sodden and crumbling away. That area below the panel had been cleaned up so no telltale signs were present at the time of sale to betray a problem without very close scrutiny (or to someone with more sense). 55 years of age and still getting stitched up!

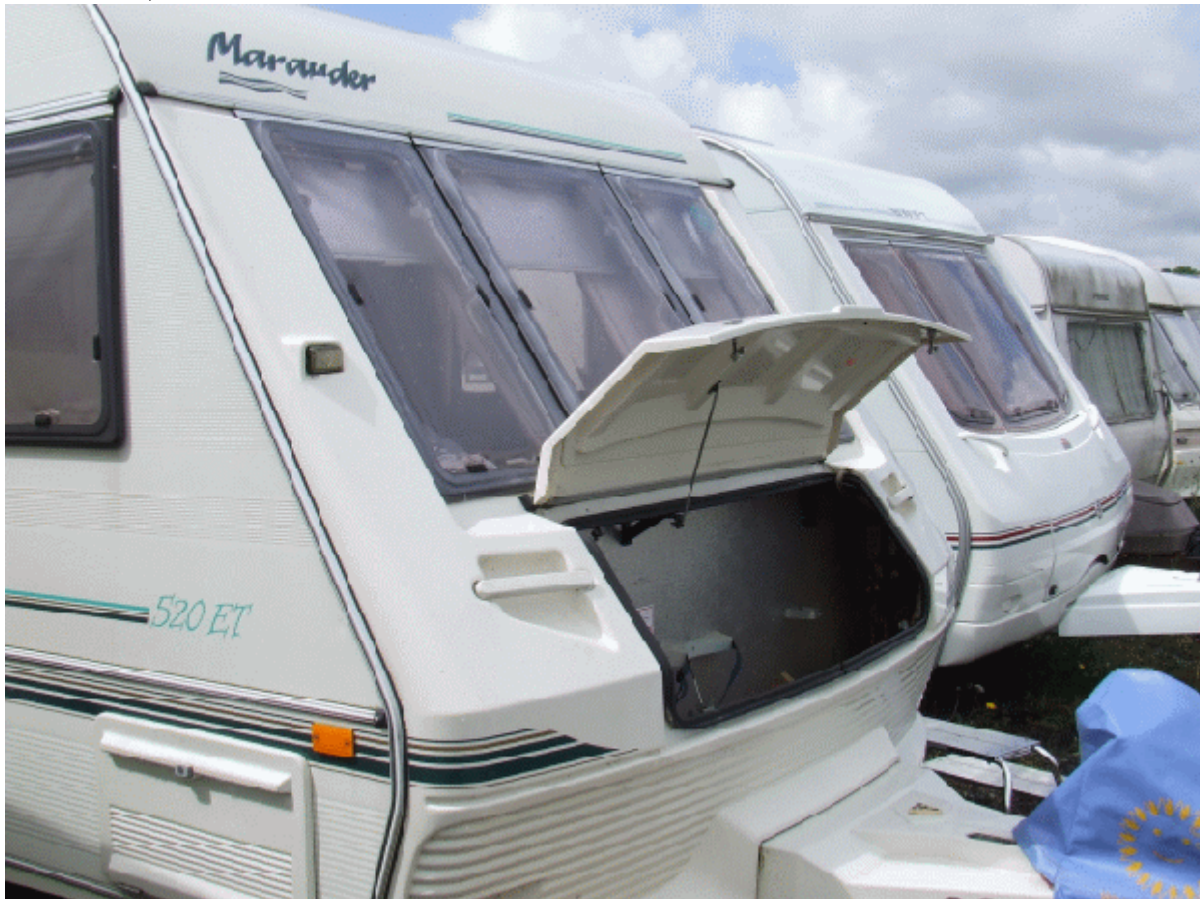
The sheet peeled back reveals the rotting and sodden timber in the nearside bulkhead,

The naughty spot was in the lower corner of the bulkhead compartment. In the shadow.

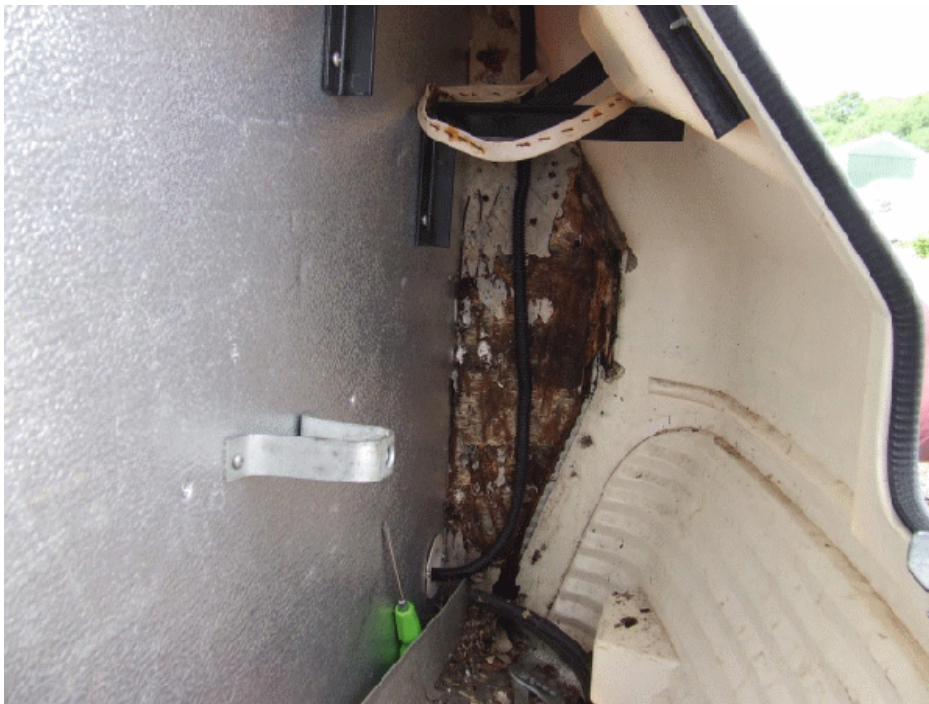
The aluminium sheet covering the known damp area in the bulkhead was first to be removed.

You can see the top layer of timber covering the insulation has discoloured with damp. Thankfully it started to harden out as it got higher. The damp (water) appears to have collected in the lower section and began its rot from the end upwards. The section 18" or so from the floor is reasonably sound. Likewise as it enters the main framework of the van.

The timber in the front locker dried out effectively and so I was able to start work. The rotten section of timber spar that was under the aluminium sheet was cut out and replaced. We were fortunate in the fact that only about 18" or so of the spar was damaged beyond repair. As I said earlier, the rot was working back from the water's journey's end in the front locker and had not reached into the main structure of the van or indeed far up the main framework.

One short length of 2" x 1" batten cut and mitred to fit was used to replace the removed section and glued and fitted together to the existing piece. Ronseal wood hardener was then applied to the sound but 'at risk' higher section and the

whole lot painted with a preservative paint. An off-cut of plyboard replaced the damaged sheet and was glued on using 'Hard as Nails'. The aluminium sheet was replaced complete with its rubber edging and stapled into position.

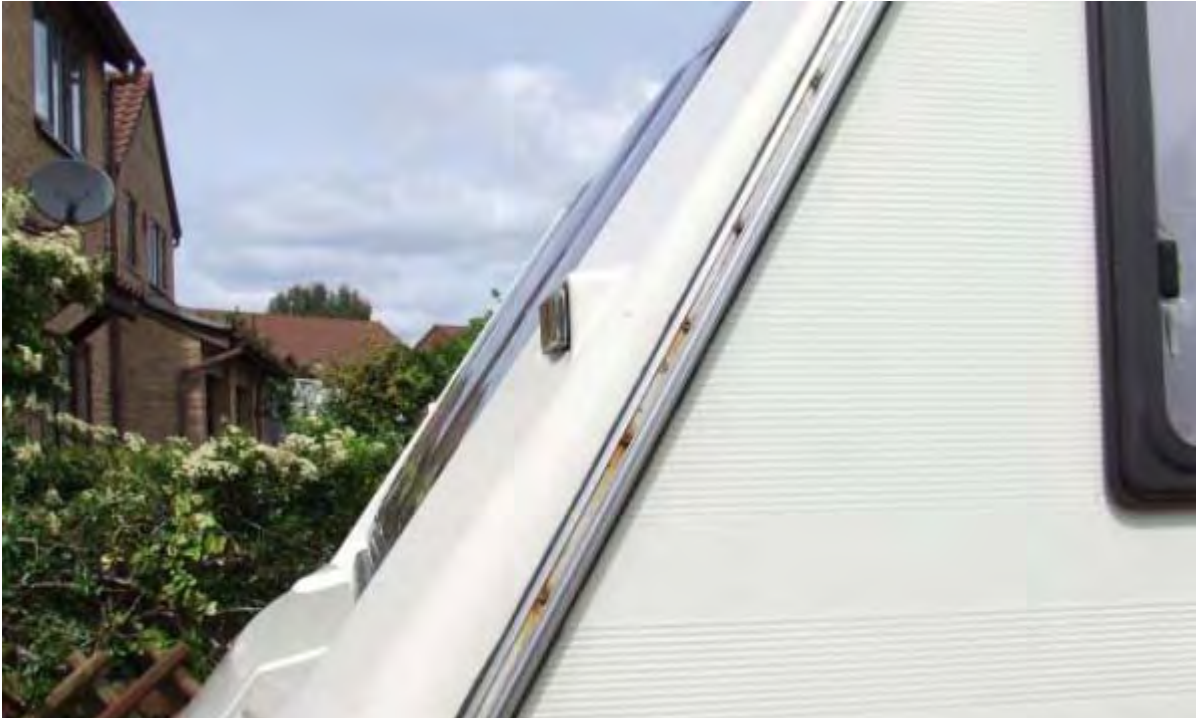
First off the plastic piping covering the screws of the rail was eased out as far as the awning rail joint, mid-way along the top side.

Removal was easier than I expected thanks to the fact that the screws were not too badly corroded and came away without damage. The rail came cleanly away without problem. Note: This definitely a two person job. All too easy to bend the rail if you try and do it alone.

The slap-dash way the mastic had been originally applied to the point where the rail curves down toward the front was apparent as you can see in the photo. Gaps everywhere!

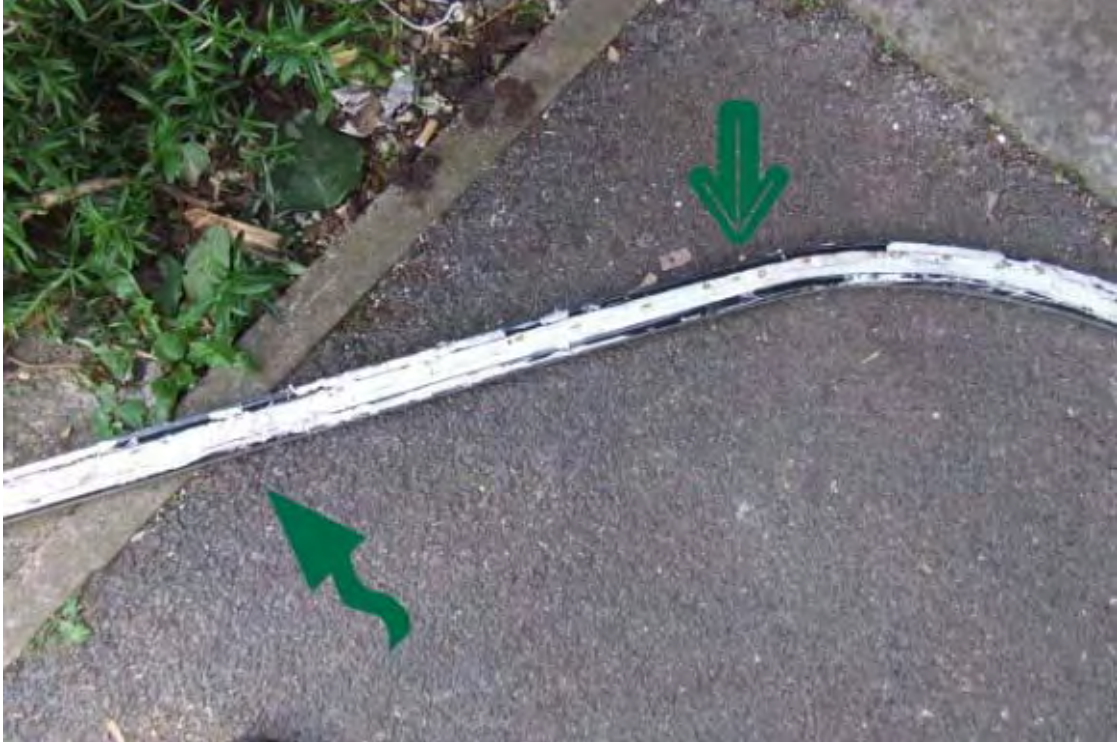
The rust stains from the staples can be seen forward of the first lean area

indicating the start of the water ingress.

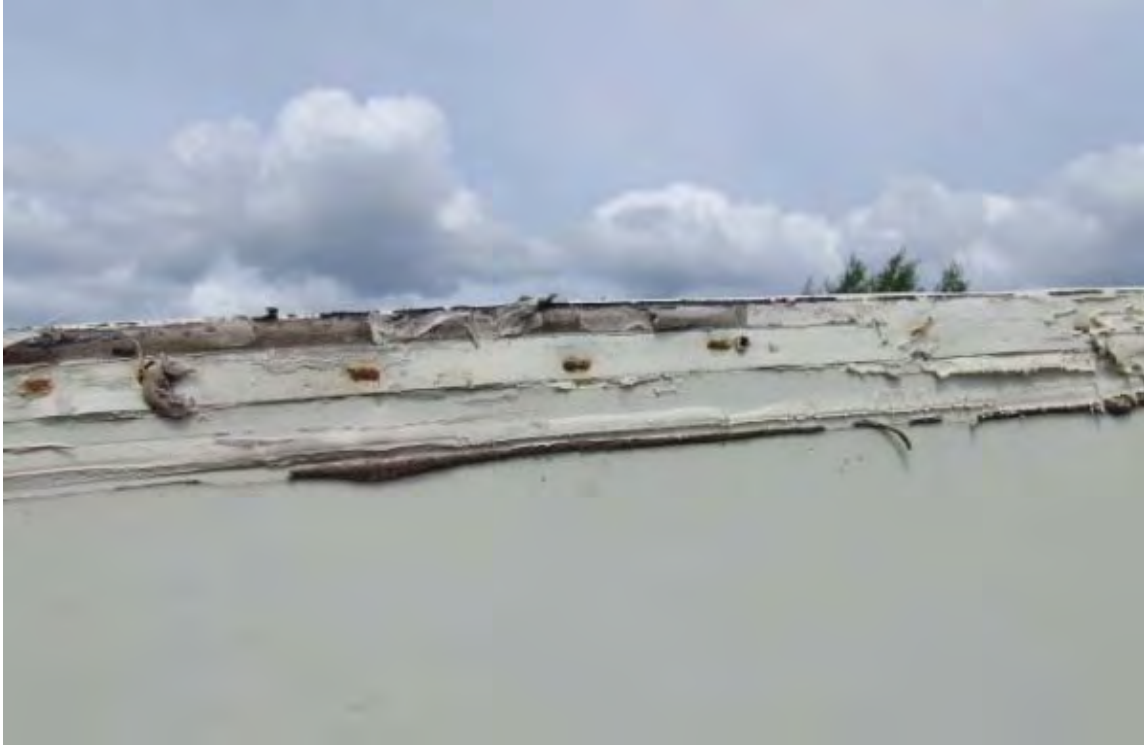
Awning rail removed, the true extent of the problem is revealed. This is the section just back from the start of the downward curve. Again, rusty staples below the patchy mastic betray the water entry points.

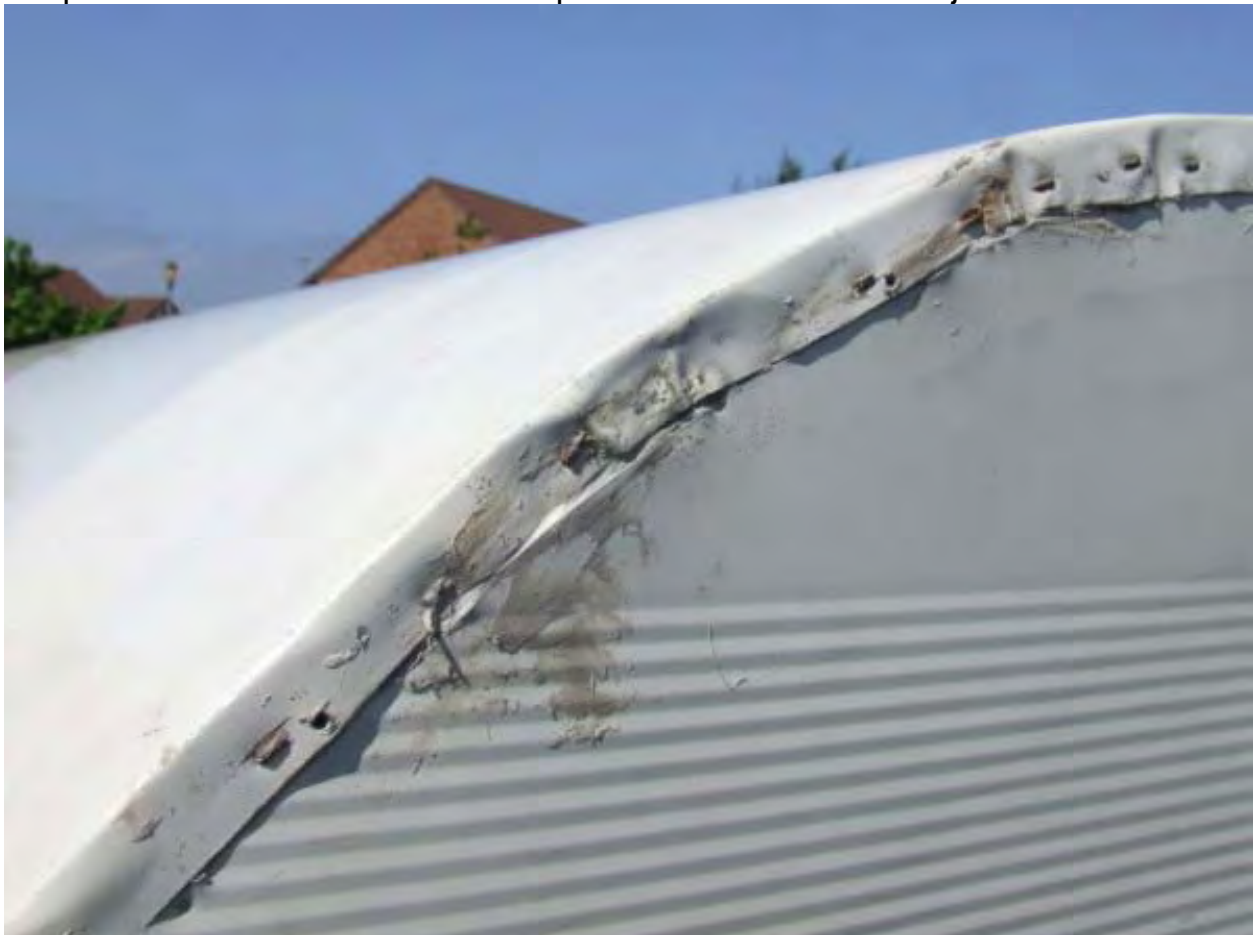
Problems with this caravan stem from the fact that the side sheet was cut short in places and does not go under the folded over roof sheet, leaving a gap. Another manufacturing blunder you can see is where the roof panel curves over toward the front. The sheet pleated on the bend and no attempt to flatten it out or God forbid, cut it properly had been made. The result was that the high rise of the pleats made channels 3/16" deep for water to run into the joint section.

Using 'Seamseal', the gaps and uncovered areas were sealed, the lumpy bits flattened down and the caravan was now better than it was when first bodged in manufacture.

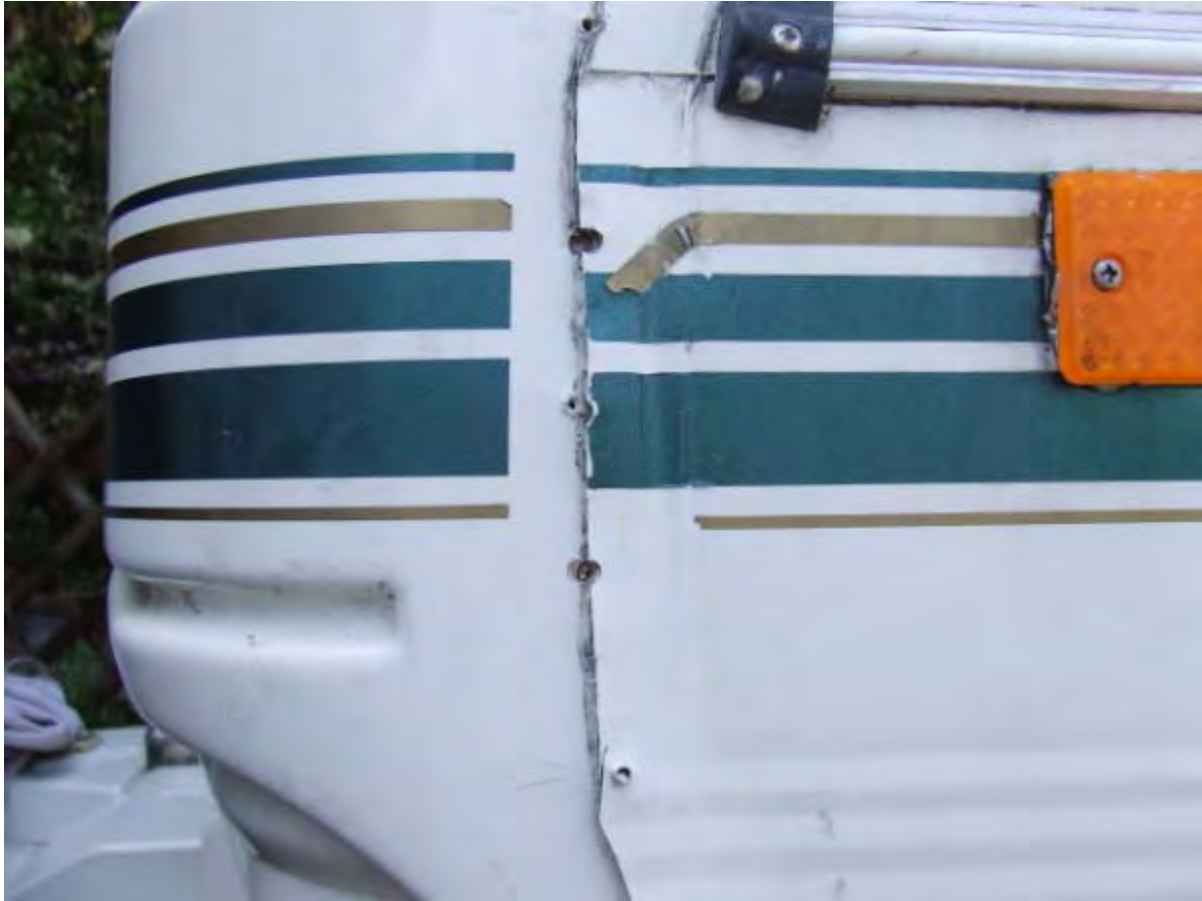
The photo below shows another 'cut short' area where the side sheet is completely missed by the screws through the awning rail where it meets with the GRP front locker.
