CARAVAN WORKSHOP

REPLACING THE BATTERY CHARGER

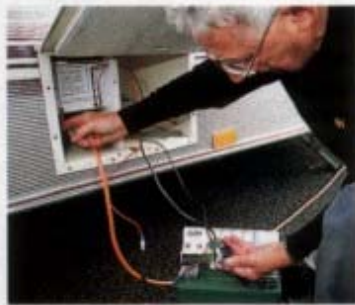
1 We spent some time checking the existing charger, wiring and fuses (*above*). Despite the mains being switched on, the test meter showed no power reaching the battery, which was totally discharged. The fuses in the van's circuits were in working order so the problem had to be in the charger itself.

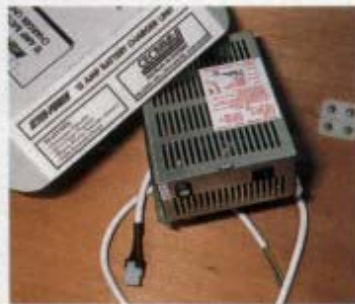
2 The CEC Plug-In-Systems Inter-Power electronic charger (*above*) is a single unit designed to be fitted adjacent to the battery. Its mains lead has a fail-safe plug at one end, the other being designed for connection to the van's mains supply. The 12v leads are fitted using spade connectors.

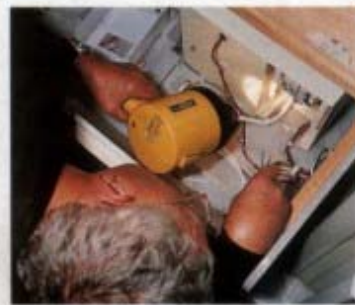
3 I needed a hand lamp to check which MCB (micro-circuit breaker) had the existing charger connected to it (*above*). As we suspected, it was the 6A MCB. I already knew from my original checks that both MCBs were working satisfactorily and current was getting to the original charger.

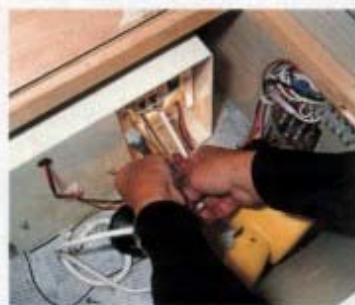
4 Having disconnected the mains power, we undid the screw at the bottom of the 6A MCB (*below*) and inserted and secured the brown (live) lead of the Inter-Power charger cable. The blue (return) cable was similarly connected to the return terminal and the earth cable to the earth terminal.

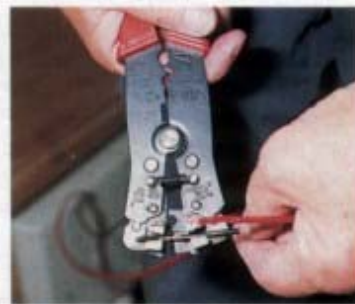
5 The next job was to fit shrouded spade terminals to the live and return leads from the charger to the battery terminals. Whenever possible, use a purpose-designed stripping tool which removes the insulation without damaging or cutting the individual copper strands (*below*).

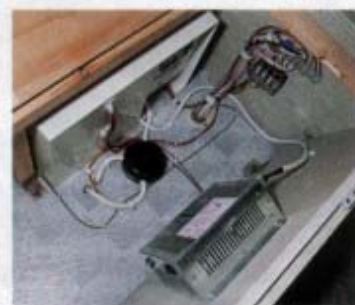
6 Luckily, the seat fronts in the Sprite are double skinned so we could fit the charger without the screws protruding through the front (*below*). We then secured the mains cable and ran the 12v leads into the battery compartment via an existing cable entry, which we then filled with silicone sealant.

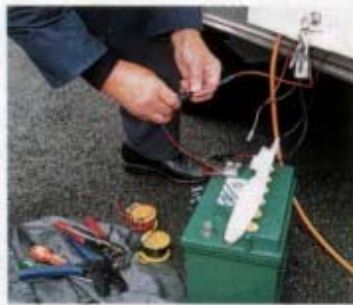
7 The live lead required a 20A fuse. On this occasion a glass fuseholder was used to avoid confusion with the blade fuse of the Truma Sonatic unit which I had previously connected directly to the battery. The fuseholder was crimped to the live lead using two tube connectors (*above*).

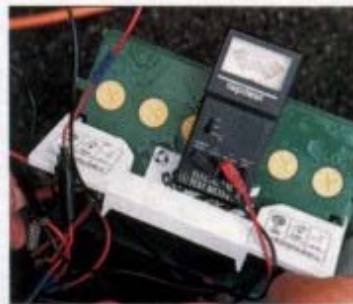
8 We reconnected the mains and checked that power was reaching the battery from the charger. Our digital multimeter had failed and we hadn't been able to buy another, so we used a Rapitest (*above*)—not as good as a digital but it could still confirm the installation was working satisfactorily.

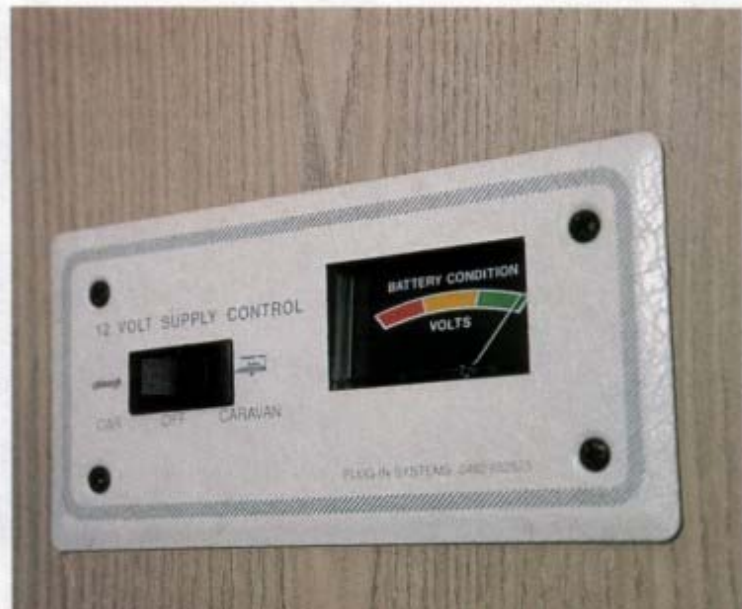
9 The final proof that the battery was being charged was the battery indicator (*below*): during our initial tests it registered zero output. It continued to register zero until the Inter-Power charger was switched on, when the needle immediately moved into the green. Andy should have no more problems.
