A stitch in time...

...saves nine, as the old proverb tells us. **JOHN WICKERSHAM** stems a small leak on his caravan by re-bedding some trim strips

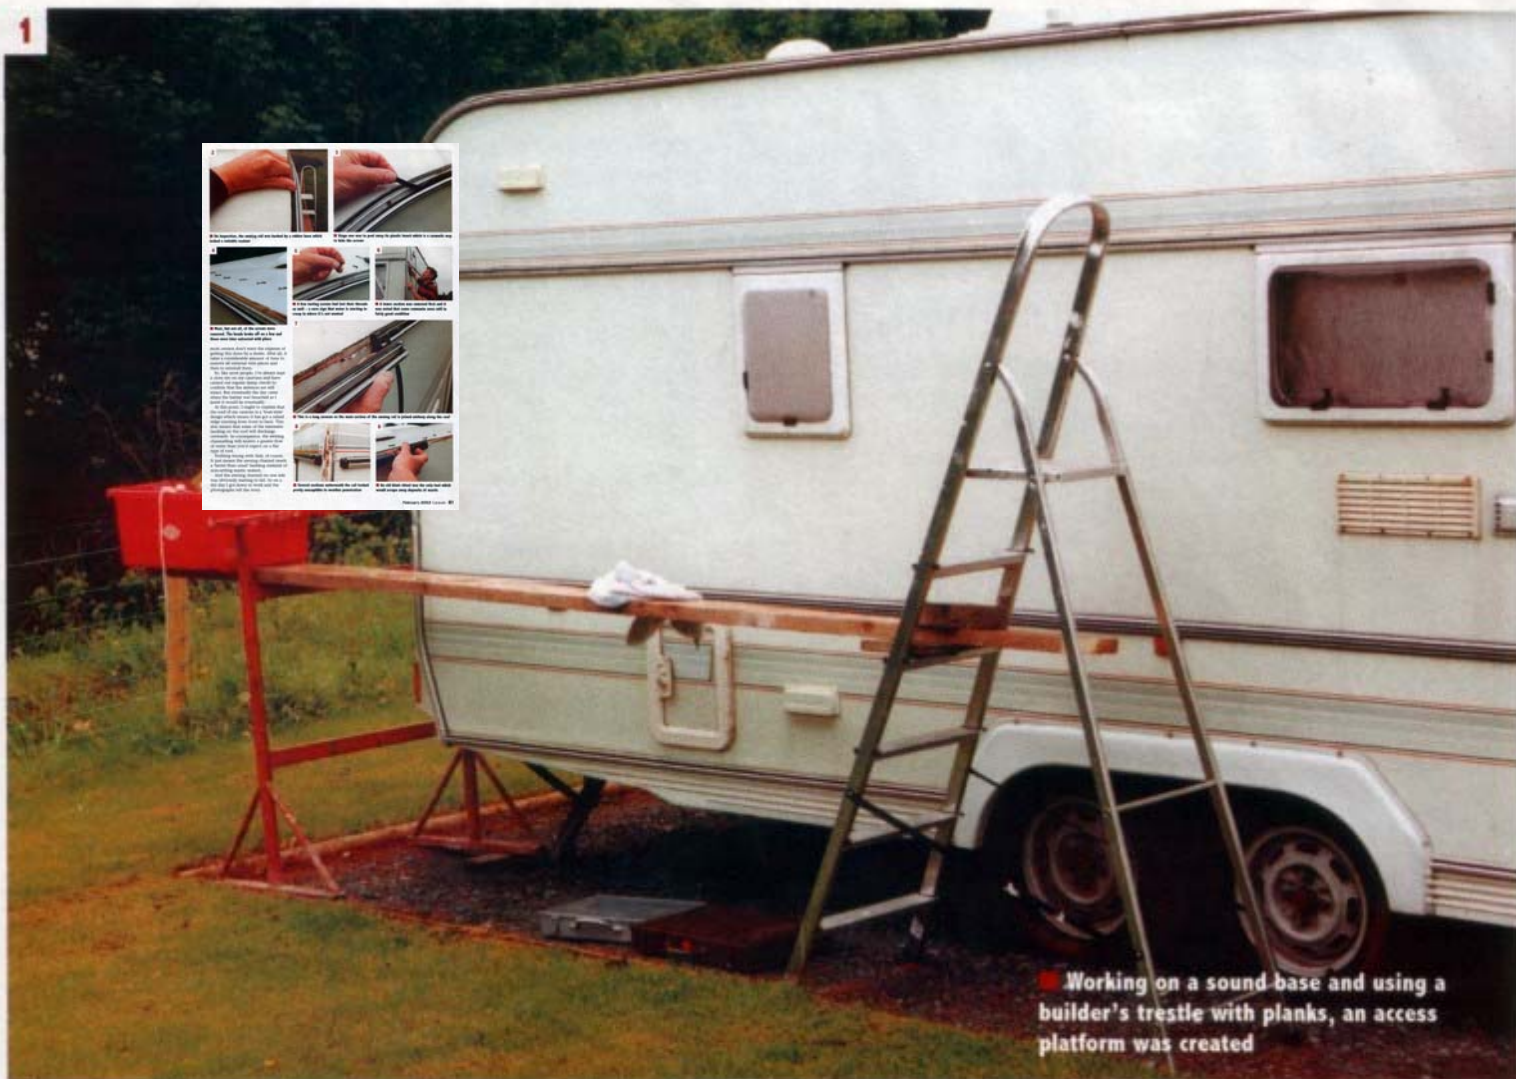
Working on a sound base and using a builder's trestle with planks, an access platform was created

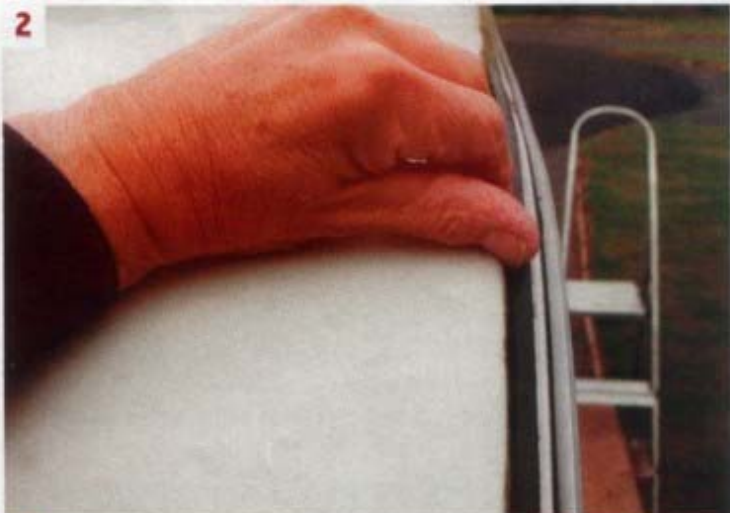
2 ■ On inspection, the awning rail was backed by a rubber base which lacked a suitable sealant

At this point, I ought to explain that the roof of my caravan is a 'boat-style' design which means it has got a raised ridge running from front to back. This also means that some of the rainwater landing on the roof will discharge outwards. In consequence, the awning channelling will receive a greater flow of water than you'd expect on a flat type of roof.

Nothing wrong with that, of course. It just means the awning channel needs a 'better than usual' bedding material of non-setting mastic sealant.

And the awning channel on one side was obviously starting to fail. So on a dry day I got down to work and the photographs tell the story.

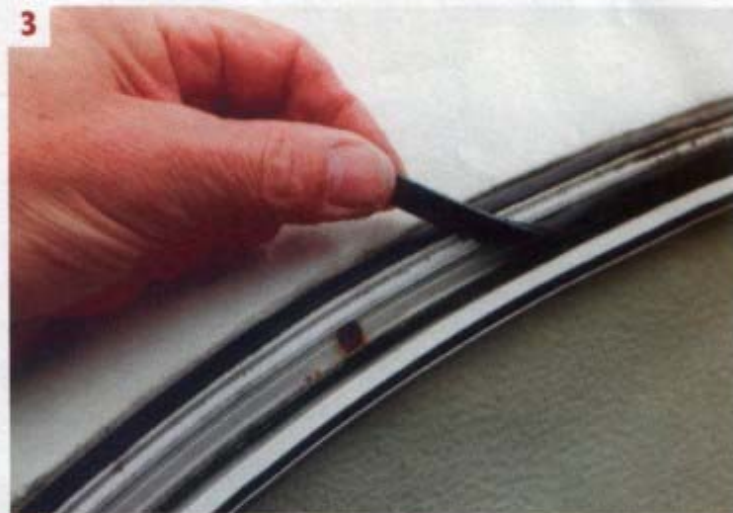
3 ■ Stage one was to peel away its plastic insert which is a cosmetic way to hide the screws

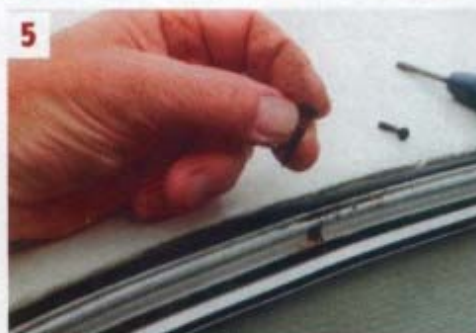
5 ■ A few rusting screws had lost their threads as well – a sure sign that water is starting to creep in where it's not wanted

Once it creeps behind the component, it then looks for another weak link in the waterproofing chain. Typically it's the screws holding the item in place and they will then start to rust. Isn't it a shame that manufacturers don't spend a bit extra fitting stainless

steel fixings? When conventional screws start rusting, your caravan has almost lost the water fight.

The threaded portion of your fixing screws will usually corrode soon after and that means you've now got a series of tiny drain holes where water can creep into the structural timbers. It happens time and time again, and my 10-year-old caravan had now joined the league of the losers.

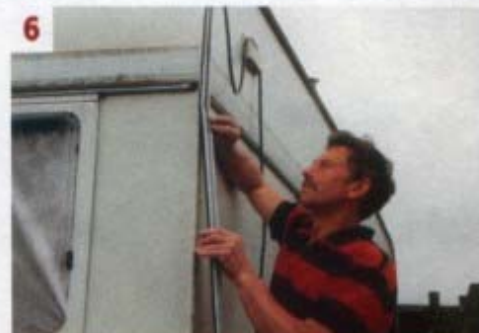
6 ■ A lower section was removed first and it was noted that some remnants were still in fairly good condition

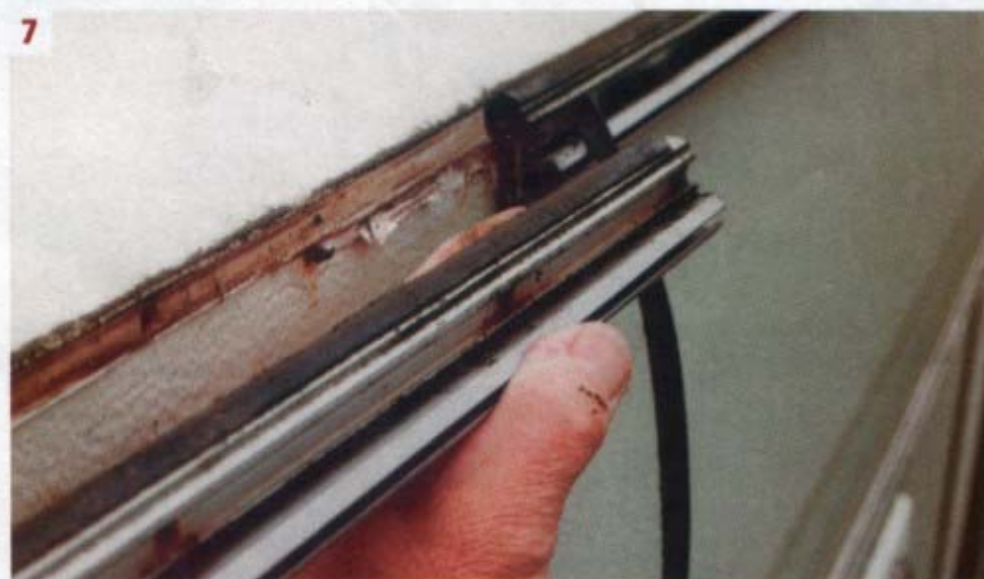
7 ■ This is a long caravan so the main section of the awning rail is joined midway along the roof

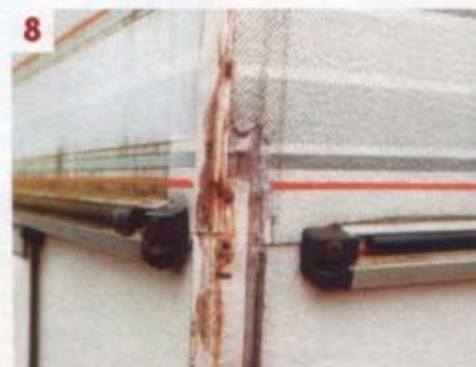
8 ■ Several sections underneath the rail looked pretty susceptible to weather penetration

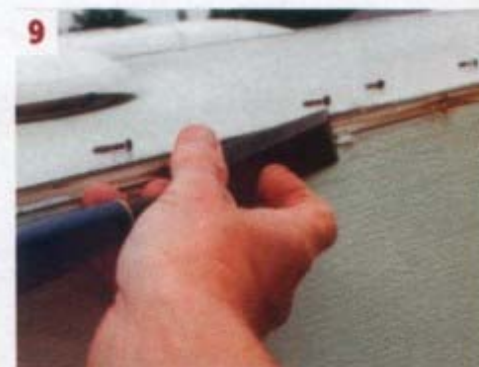
9 ■ An old blunt chisel was the only tool which would scrape away deposits of mastic

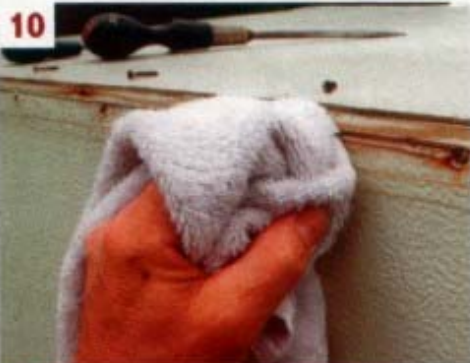
10 ■ Turps substitute seemed to help in the cleaning-up process, but it took quite a time to completely tidy up the surface

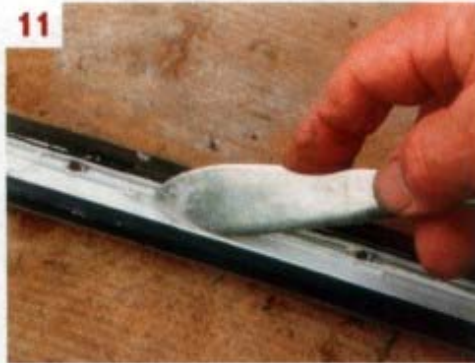
11 ■ An old fish knife is my favourite tool for getting into tight spaces such as removing sealant from the rear side of the channelling

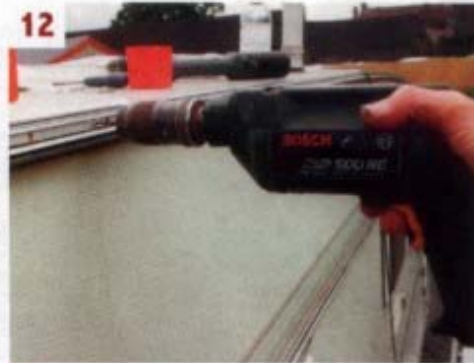
12 ■ The channel was temporarily re-fixed so that fresh holes could be drilled to receive replacement screws

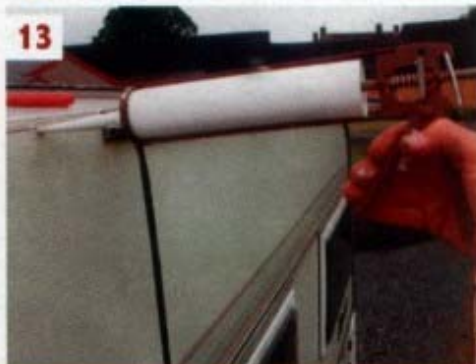
13 ■ Sealant was pumped into all the holes, both the original ones and the new holes for replacement fixings

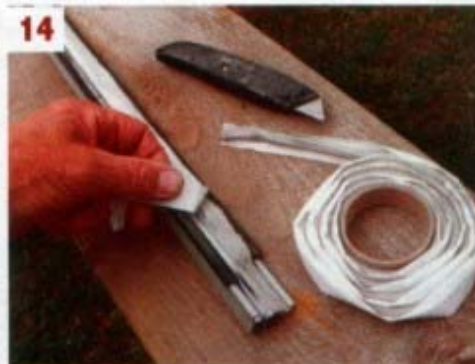
14 ■ A narrow band of ribbon sealant was pressed deeply into the moulding channels on the reverse face of the awning rail

Needless to say, this isn't the only way to re-bed and re-attach external fixtures and fittings. For instance, my personal preference is to use a bedding sealant in ribbon form because it gives an assurance that a consistent application of sealant has been carefully and accurately positioned.

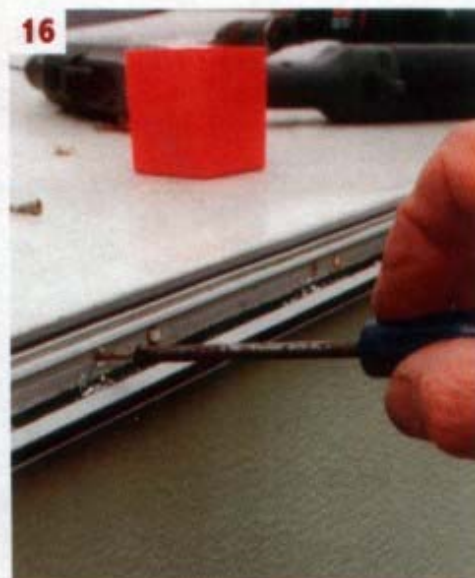
16 ■ Once the new holes had been finally prepared with a countersink, the new screws were driven home

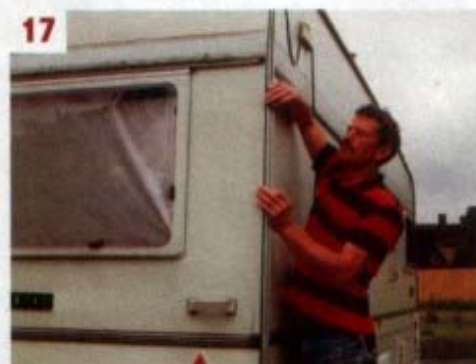
17 ■ Each section was pressed firmly into the bedding sealant, taking care to ensure there was continuity in the channelling groove

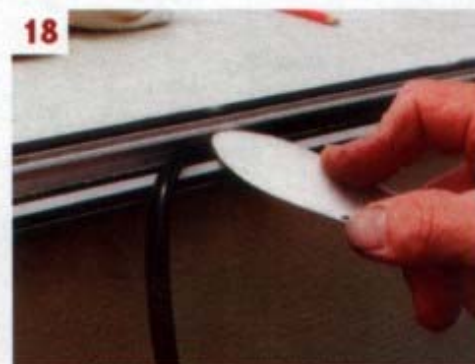
18 ■ The plastic trim was re-inserted next. Then a thin bead of Sikaflex 221 was injected along the roof edge of the awning rail itself

Then there's the Sikaflex method of fixing. I don't mind admitting that I've found Sikaflex products extremely good in the last few years. What's more, a product like Sikaflex 221 isn't just a sealant. It is also an adhesive and its ability to bond items together is little short of remarkable.

If it's good enough to stick a car's windscreen to a metal surround, I don't need any more convincing about its structural credentials.
