# The right input

**Matt Stubbs** concludes installation of a new mains electrical system in our old Sprite project caravan, fitting an appropriate inlet socket

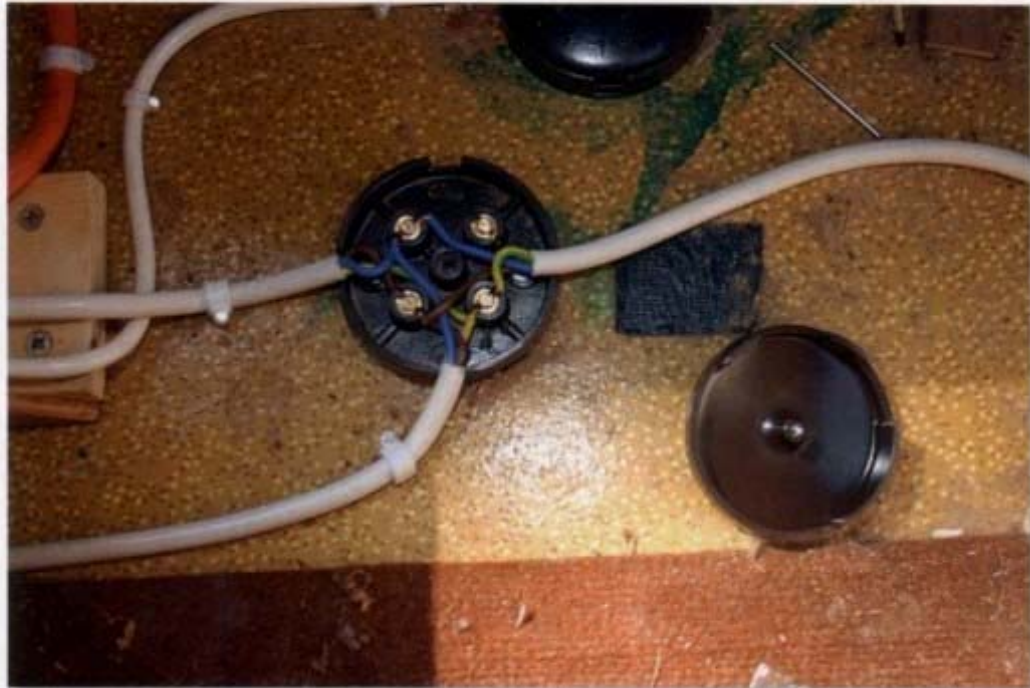
**1** I had connected the consumer unit to two junction boxes, one cable being rated at 10 amp capacity and the other 6 amp. I intend to use the 10 amp for the mains sockets and 6 amp for lights and fridge

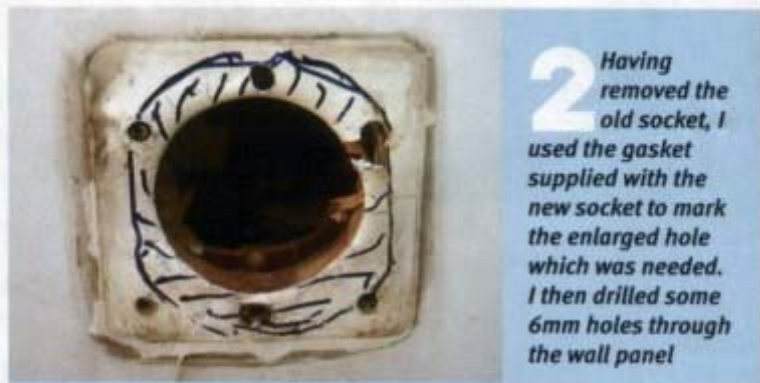
**2** Having removed the old socket, I used the gasket supplied with the new socket to mark the enlarged hole which was needed. I then drilled some 6mm holes through the wall panel

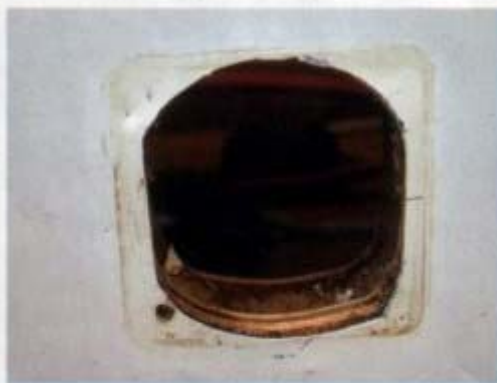
**3** The old rule 'cut undersize and open the hole up' applied here. Having cut the hole undersize, I used my power file gradually to remove material until the socket fitted

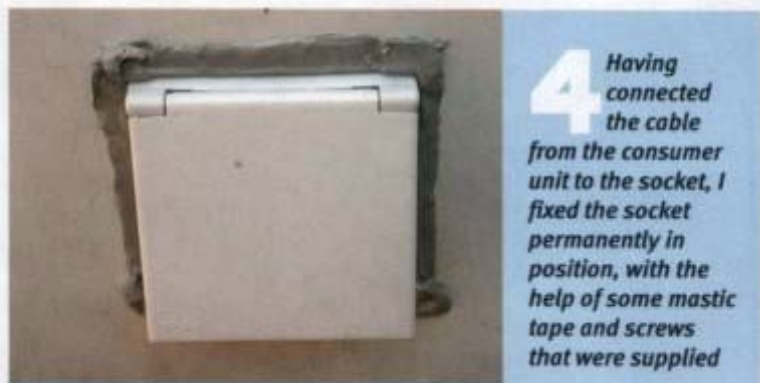
**4** Having connected the cable from the consumer unit to the socket, I fixed the socket permanently in position, with the help of some mastic tape and screws that were supplied

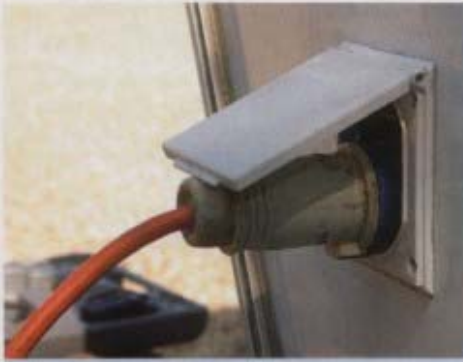
**5** Before testing the system, I went under the caravan and made sure that the earth connection to the caravan's chassis was sound. Then I connected to the site mains

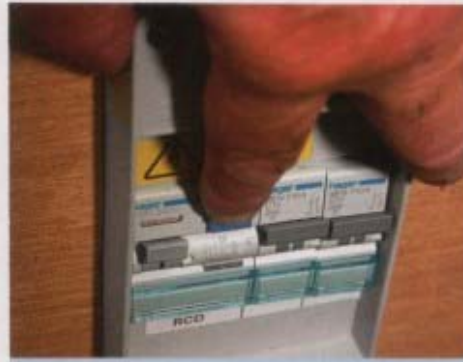
**6** Once I had connected to the site mains, the next job was to test the trip on the RCD unit. As soon as I pressed the test button the unit tripped out, cutting power, so all was fine

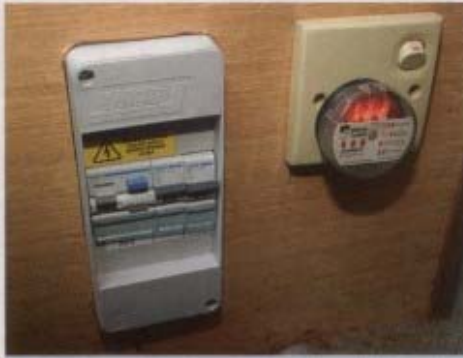
**7** Having confirmed that the consumer unit was functioning properly, I checked that the 13 amp socket I had installed was wired properly, using my plug-in mains tester

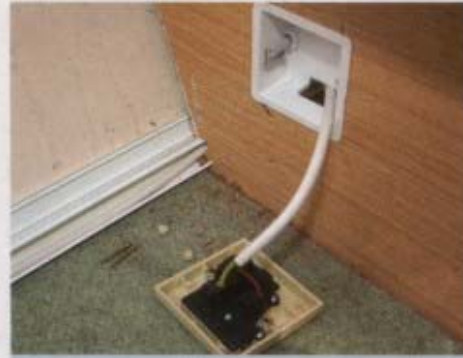
**8** Having removed a continental-type socket here, I fitted a new mains socket. I ran cable round the van using some plastic ducting to protect it, seen on the left of the picture

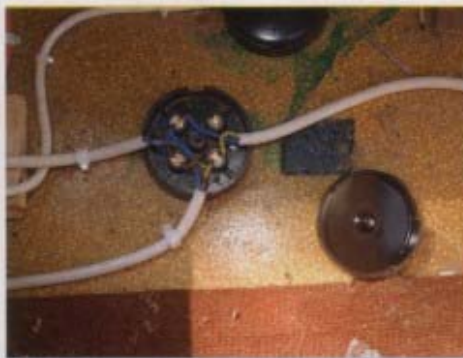
**9** In the front nearside seat I connected the cable to the 10 amp junction box: brown (live) to brown; blue (neutral) to blue; and green/yellow (earth) to green/yellow

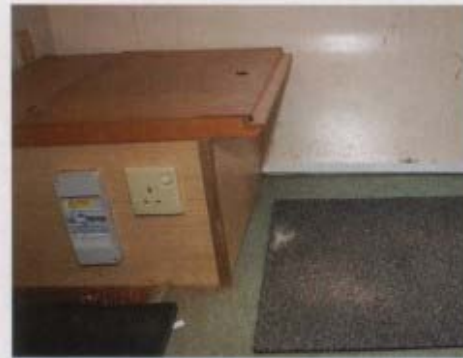
**10** After connecting the junction box, I reconnected the mains and used my mains tester to check that the whole system was fine. I think the installation looks very neat

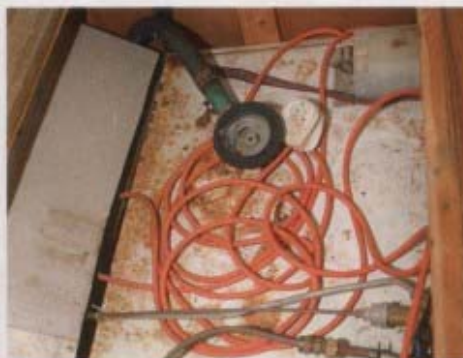
**11** The final job was to remove the sink and drainer, and the hob and grill unit, which will eventually be replaced. I found this cable which was the old supply to the fridge

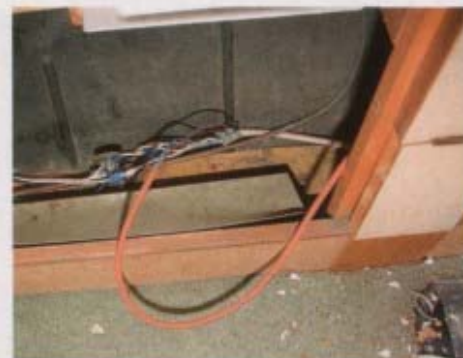
**12** You can get some idea of the standard of wiring in the van from the state of the cables in the base of the kitchen unit. All were very light capacity and poorly connected
