Potential disaster avoided!  
Another repair by [Ukcampsite.co.uk](http://Ukcampsite.co.uk) member [Floggitt](#)

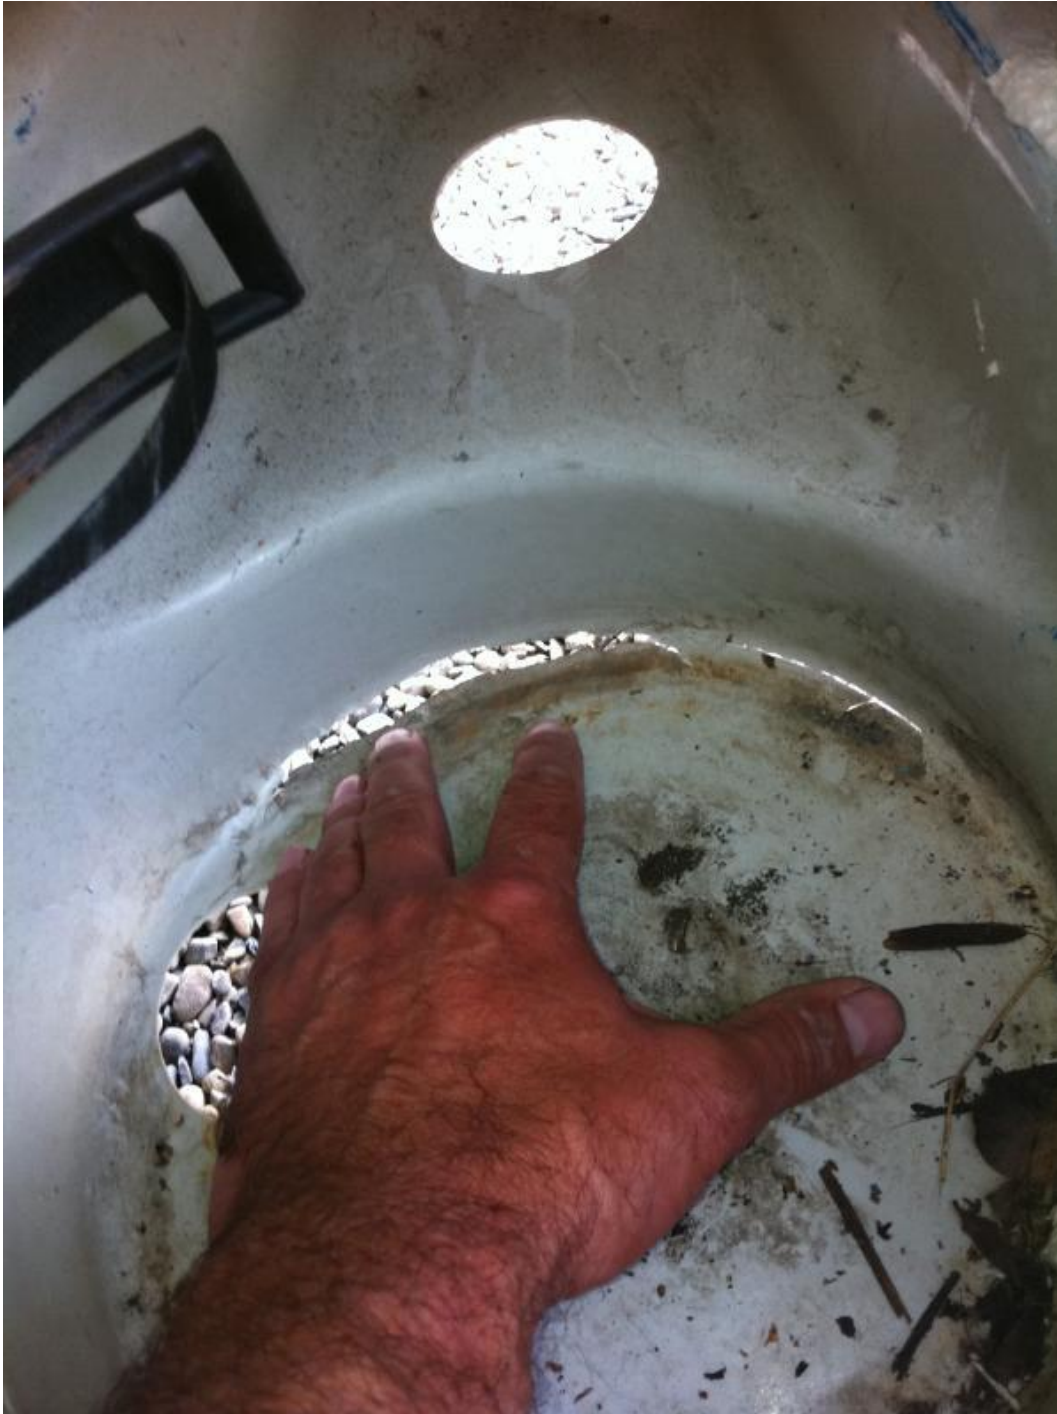
I had a look underneath the front locker and was horrified, with the weight of a 6kg gas bottle the bottom of the holder was hanging out the plastic has cracked half of the way around!

If that had broke the rest of the way in our travels the gas bottle would have fell though the bottom and on to the road.
