Replacement of broken glass window

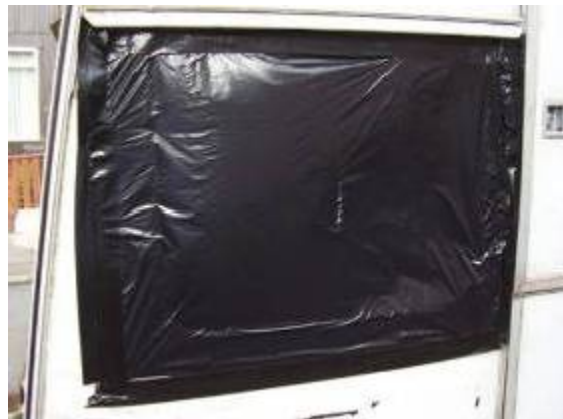
First I Took whole frame out, as there is no other way to do it. This involves removing all the screws from both the outside and the inside of the frame.

At this point I taped a plastic sheet to the hole left in the caravan where I had removed the window. This helped to keep the weather out and stop prying eyes! I used Duck Tape to hold the plastic sheet in place, Quaking good stuff but can be a problem removing the sticky residue when removing, in the end I found surgical wipes did remove it well.

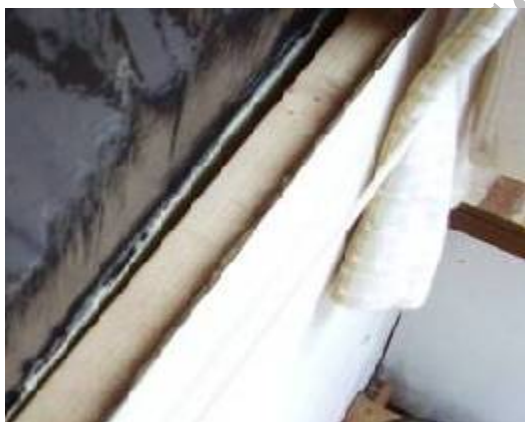
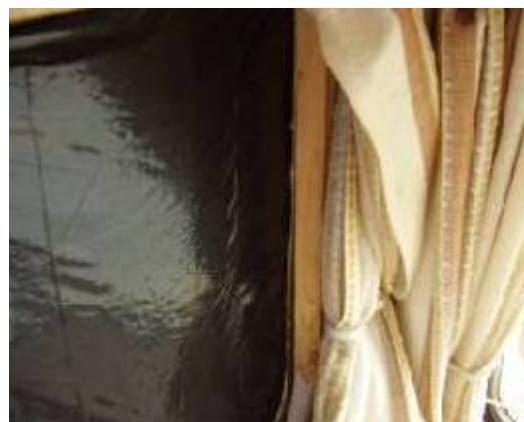
I had a good look at the exposed wooden frame which is as good as new, same colour as new stuff and no hint of damp so that's one less wall to worry about! Not bad for a 29 year old van. I also noticed at the time of the window removal that the original sealant was still in a tacky state which meant it was still working; in fact it was a bit tricky prying out the frame away from the sealant.

The timber frame is in great condition. 29 years since being built!

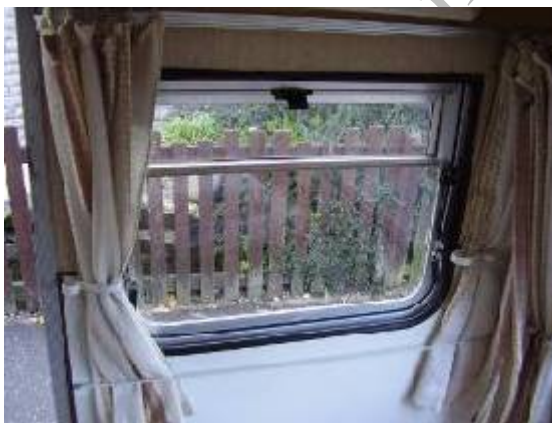
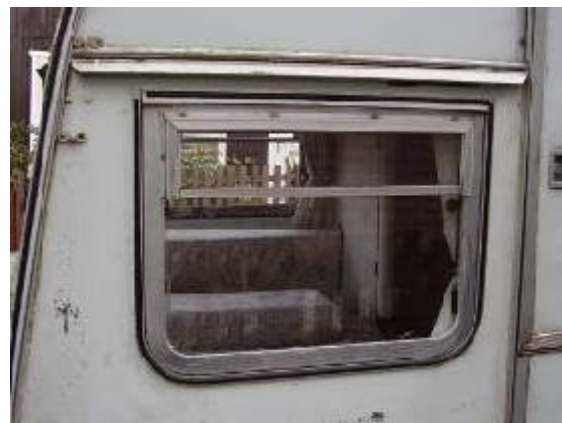
Window in situation again!

Unfortunately in this case the glass edging strip was past repair/use so I had to resort to using the sealant gun, not one of my favourite tools!

I used 4mm thick Bayer Toughened safety glass, vandal proof according to the local glazier. A sheet of 1ft x 2ft cost me £12 which I thought was OK.

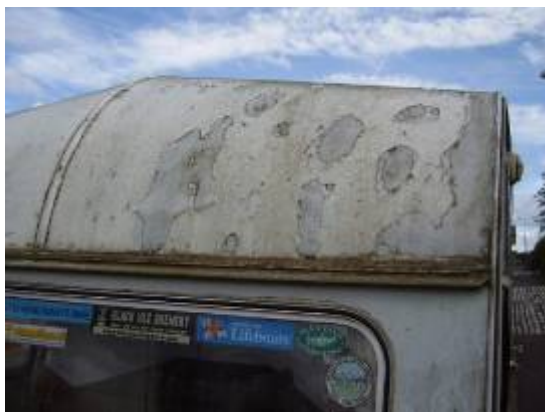
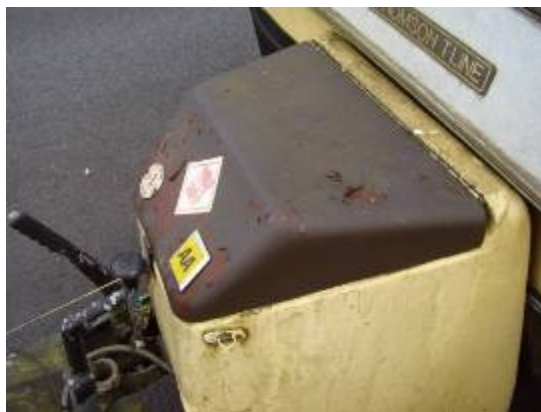
Still plenty of work needing doing to the van including a good wash and repair to paintwork.

Now all we have to do is clean it and replace the now very faded real lamp lenses which are almost white on the orange section. The painting Jobs will have to wait for a few weeks.

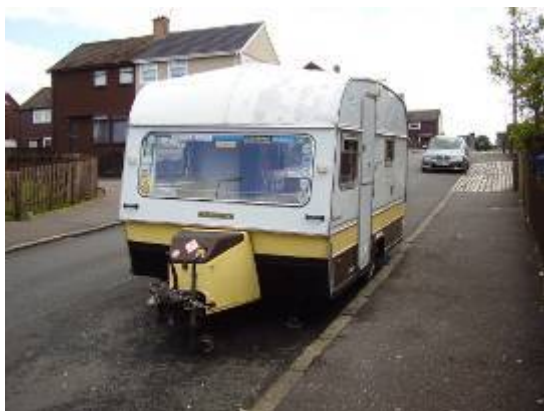
Washed ready to paint

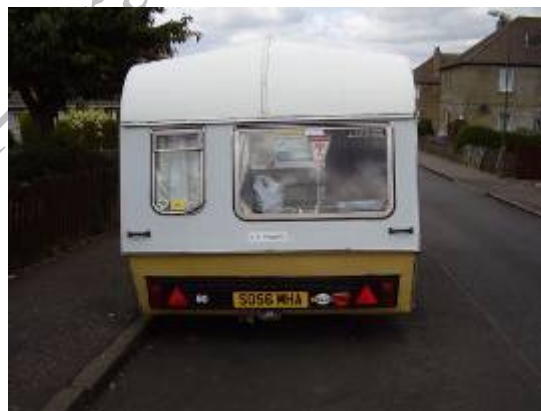
New lamp lenses fitted
