Replacement of broken glass window

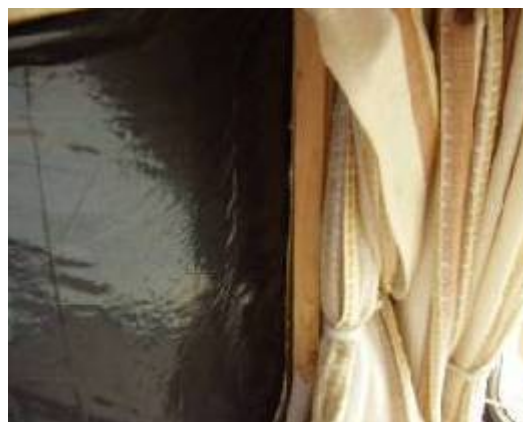
I had a good look at the exposed wooden frame which is as good as new, same colour as new stuff and no hint of damp so that's one less wall to worry about! Not bad for a 29 year old van. I also noticed at the time of the window removal that the original sealant was still in a tacky state which meant it was still working; in fact it was a bit tricky prying out the frame away from the sealant.

The timber frame is in great condition. 29 years since being built!

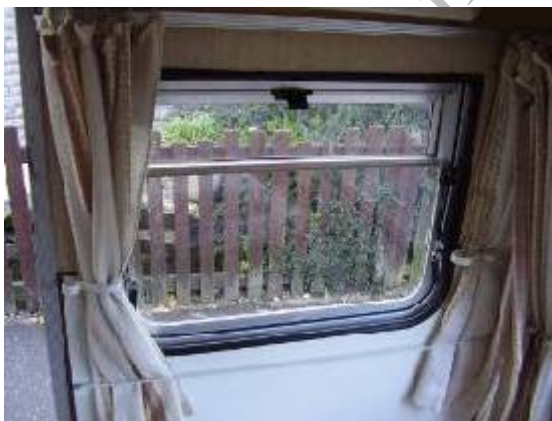
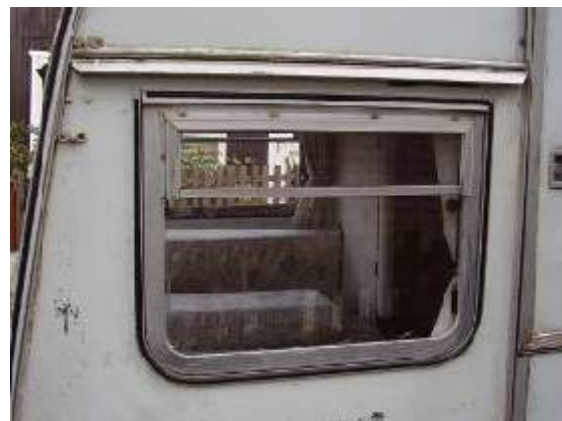
Window in situation again!

I used 4mm thick Bayer Toughened safety glass, vandal proof according to the local glazier. A sheet of 1ft x 2ft cost me £12 which I thought was OK.

Unfortunately in this case the glass edging strip was past repair/use so I had to resort to using the sealant gun, not one of my favourite tools!

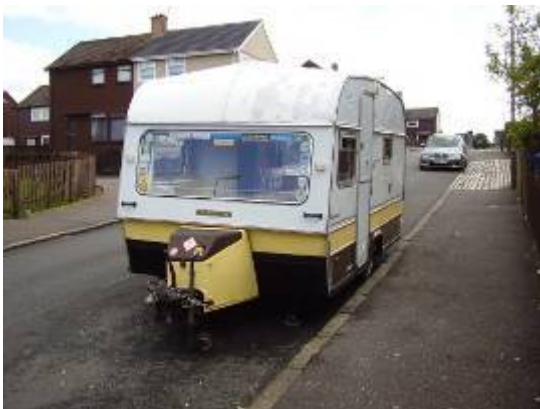
Washed ready to paint

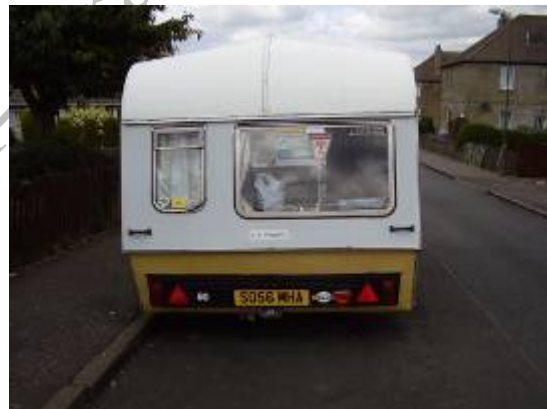
New lamp lenses fitted

Now all we have to do is clean it and replace the now very faded real lamp lenses which are almost white on the orange section. The painting Jobs will have to wait for a few weeks.
