Bearing in mind! By Paul Camilli

Whilst there was nothing actually wrong with the wheel bearings on my 1971 Glenelg one of the grease seals was leaking.

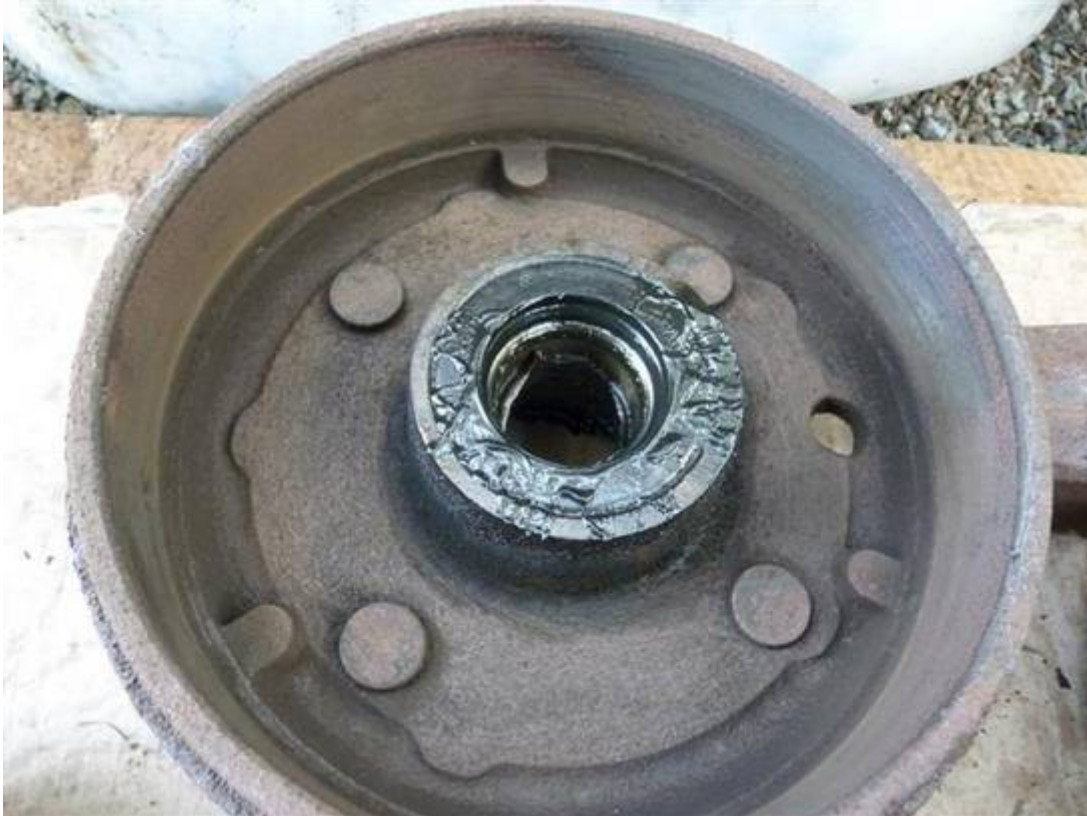
The hub/drum can then be slid off the stub axle, taking care not to damage the threads.

Once that's off you can inspect the brake shoes and stub axle,

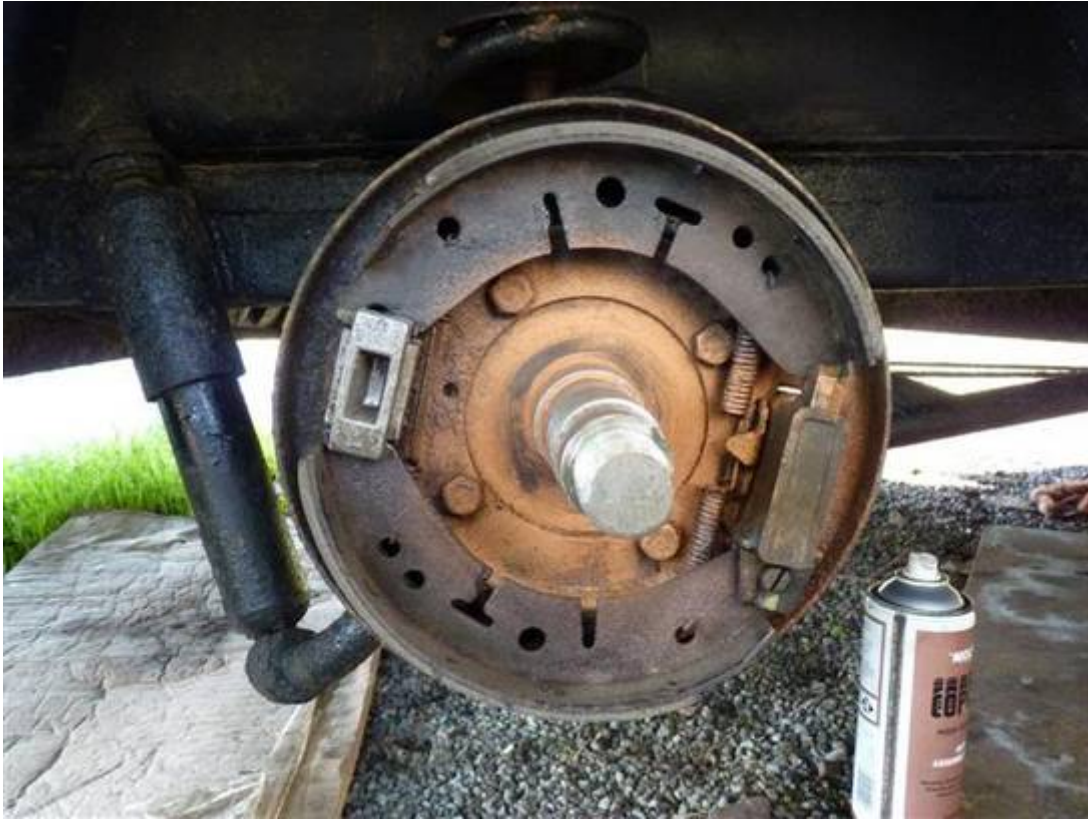
If the part of the axle that the seal runs on is worn you can remove it and turn it around. On most vehicle axles this is part of the stub itself and if worn the axle is scrap. On the B&B chassis however it is a separate bush that slides over the shaft. It's not obvious at first but careful cleaning will reveal it and gentle prizing with a sharp screwdriver between the bush and backplate should slide it off.

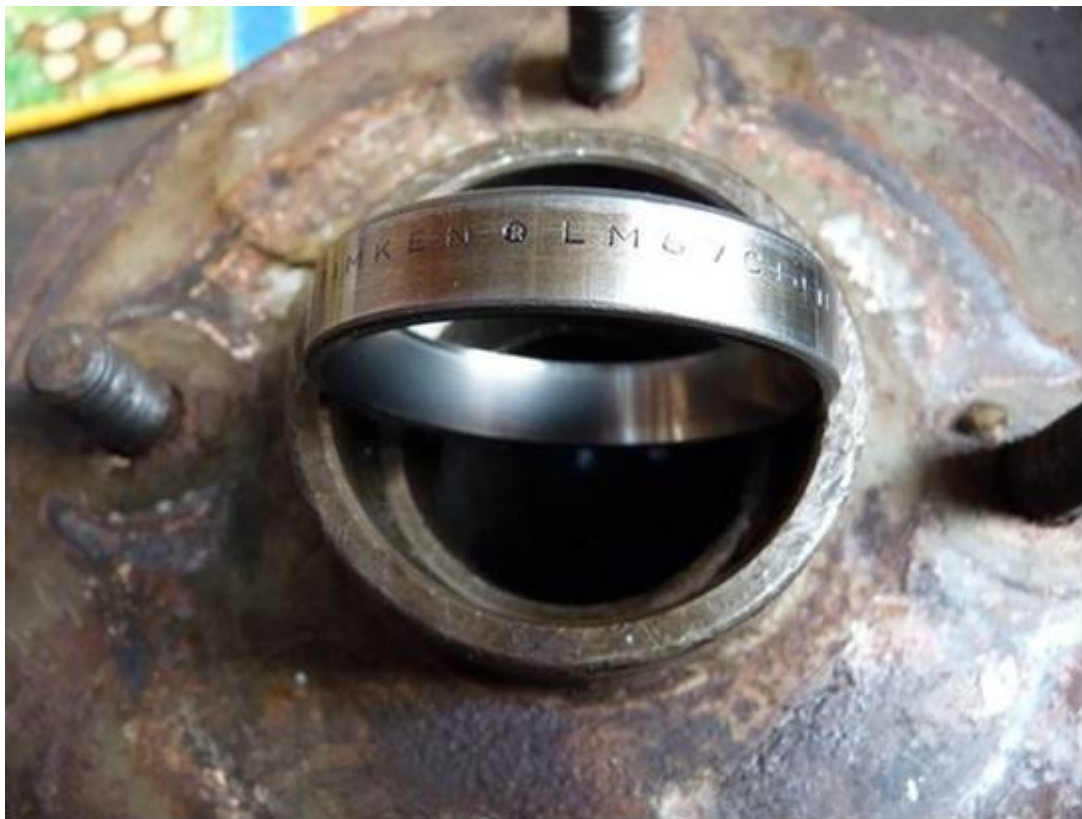
There was actually nothing wrong with the bearings other than a leaky seal but I removed them anyway to get the numbers off them for future reference.

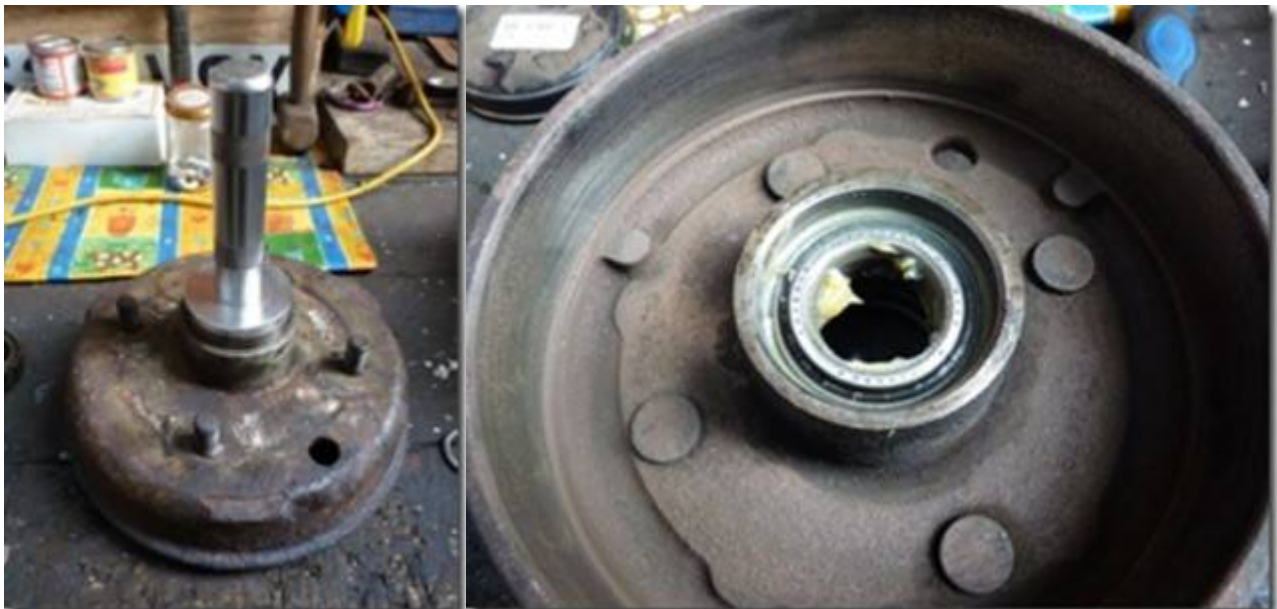
The picture on the left is fitting the outer bearing using a special aluminium drift but anything that presses evenly on the outer race will do. The right hand one is the inner bearing fitted, greased and ready for the seal.

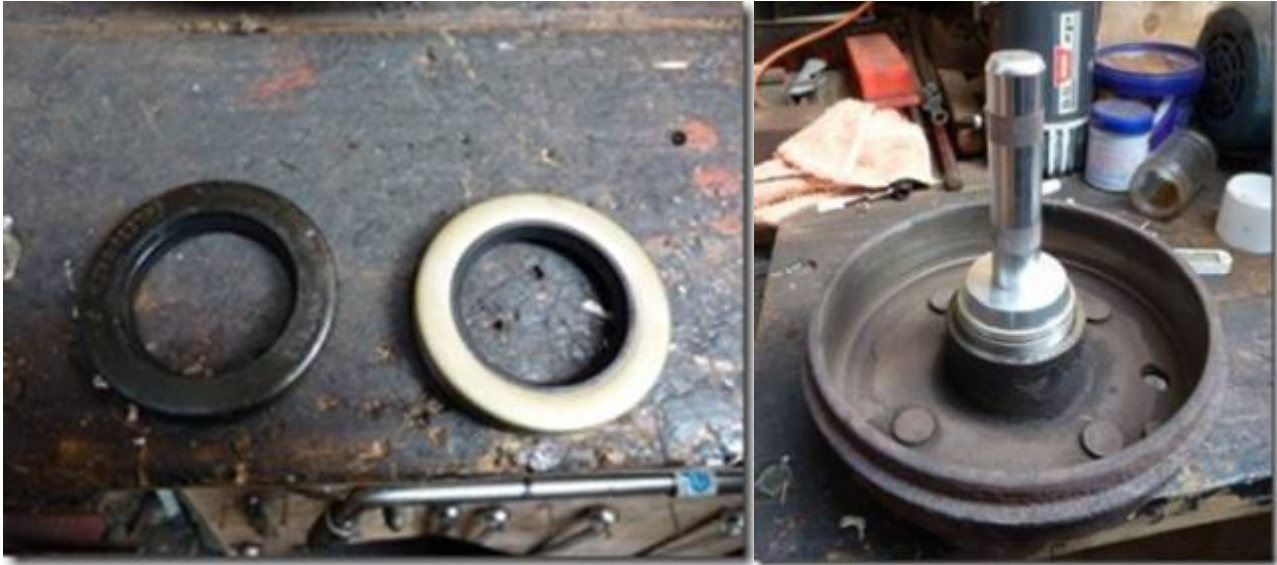
The picture on the left shows the old and new seals and the one on the right drifting the seal in with the same tool [available on Ebay = Bearing & Seal installer/ Driver Set. T442200](#) though I'm sure mine was half that price. Mind you it was a long time ago 😊

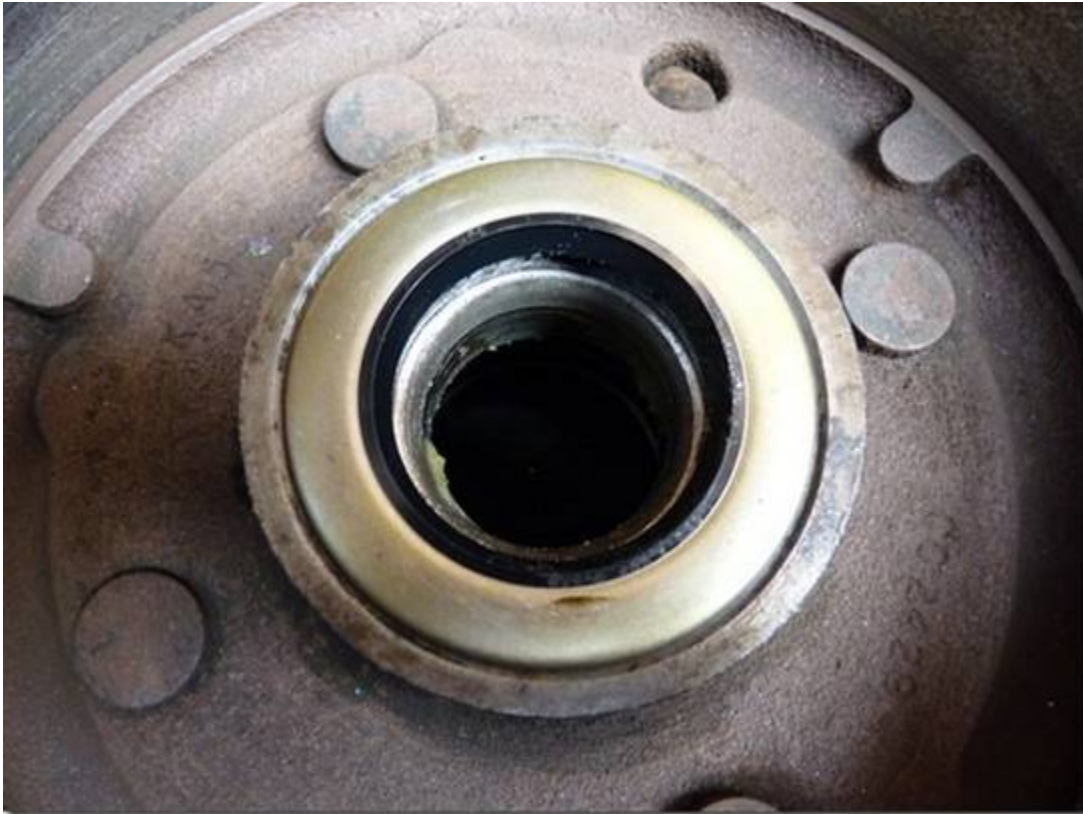
Here's the new seal fitted and it's important not to drift it in too far, just flush with the edge of the drum is fine, any more and the seal will not mate with the bush that it runs on.

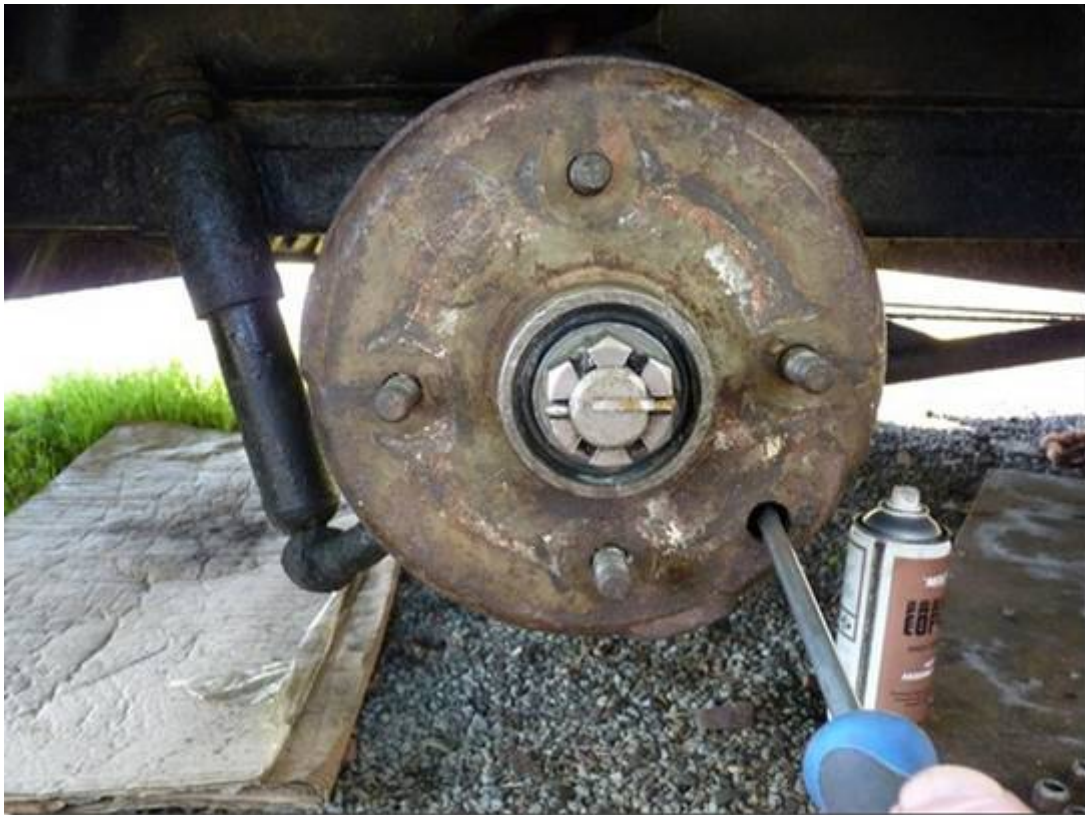
All was fine in the brake shoe department, a little light rust was sanded off the drums and a bit of copper grease applied to the moving parts was all that was required. The brakes are easy enough to adjust; you just tighten them up with a screwdriver then back them off till they stop binding.

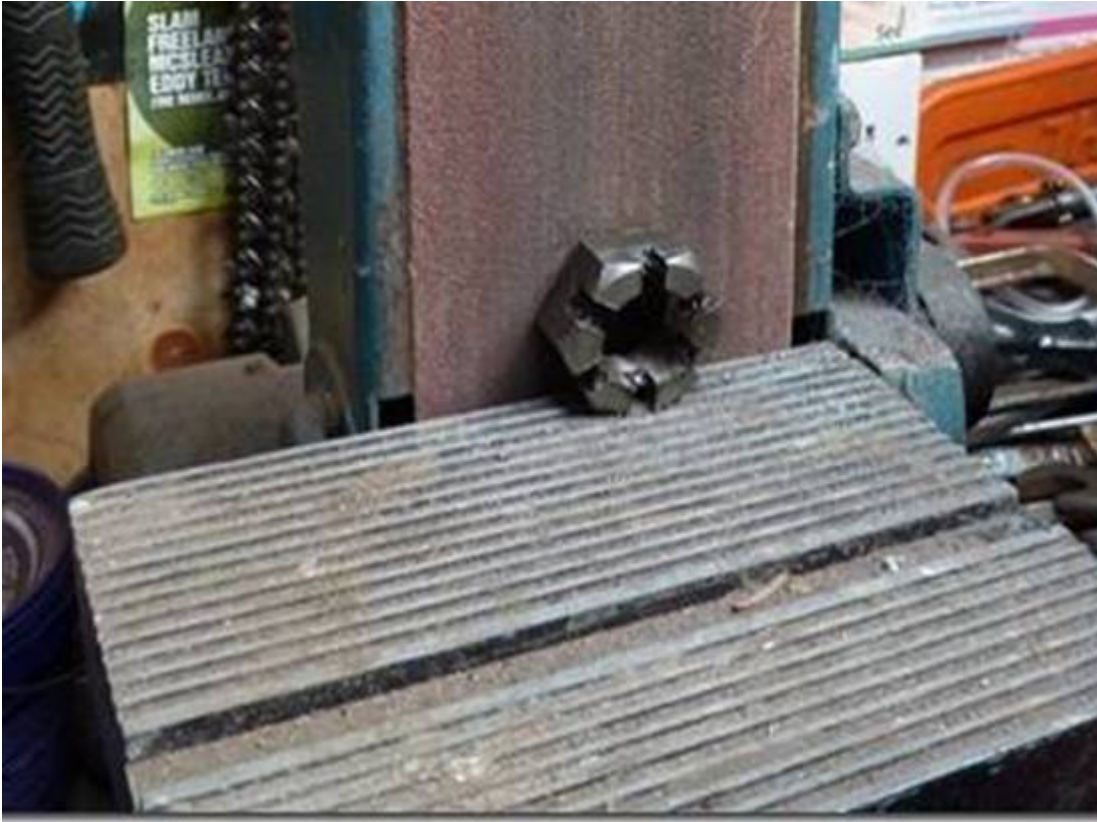
Now the slightly tricky bit 😬 you will more than likely find that with the wheel bearing play gone that the split pin hole does not line up. To remedy this DO NOT TIGHTEN the nut any more, remove it and do one of two things. Carefully file or grind the base of the nut until it does line up or just add thin washers or a combination of both.

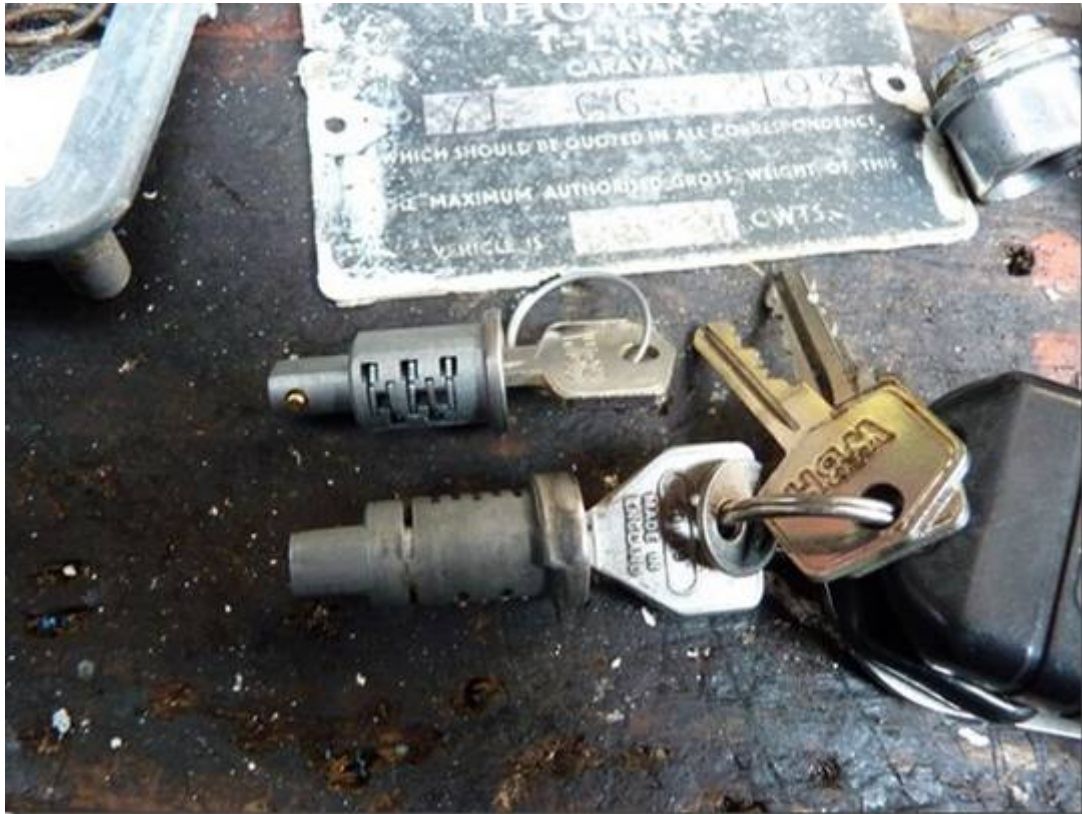
After I turned my attention to the door lock on our caravan, we only have one key and a spare was proving impossible to find. Fortunately I had a spare Land Rover barrel and key which I modified to fit into the caravan lock 😊
