1990 SERVICE MANUAL PM13/1

REVERSING BRAKE
for
Caravans and Trailers

Introduction: (Rod operated version)

Introduction: (Cable operated version)

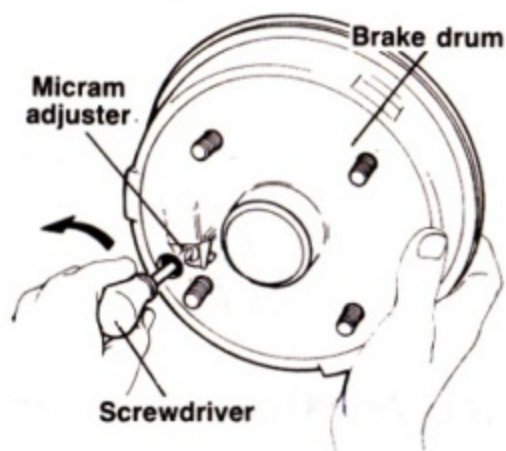
1

Line up the hole in the brake drum with the slotted head of the micram adjuster. Back off all brake adjustment with a suitable screwdriver by turning the micram fully anti-clockwise.

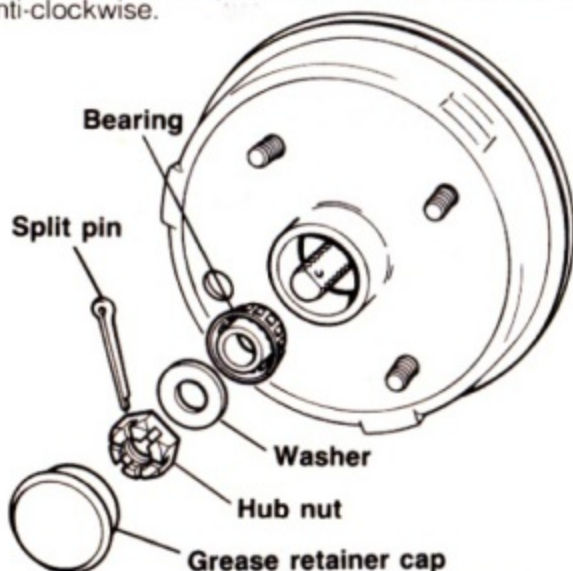
2

Prise off the hub grease retainer cap and remove split pin, hub nut, washer and bearing. Withdraw the brake drum from the stub axle.

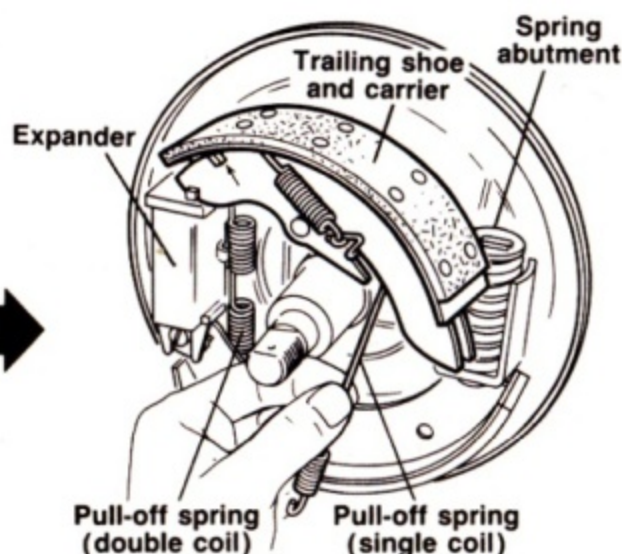
3

Release the pull-off spring (**double coil**) from behind the hook on the backplate, adjacent to the expander. At the opposite end lift the carrier and shoe away from the spring abutment and disconnect the pull-off spring (**single coil**) from the leading shoe web. This spring is identified, **red** for L.H. brake assembly, **black** for R.H. brake assembly.

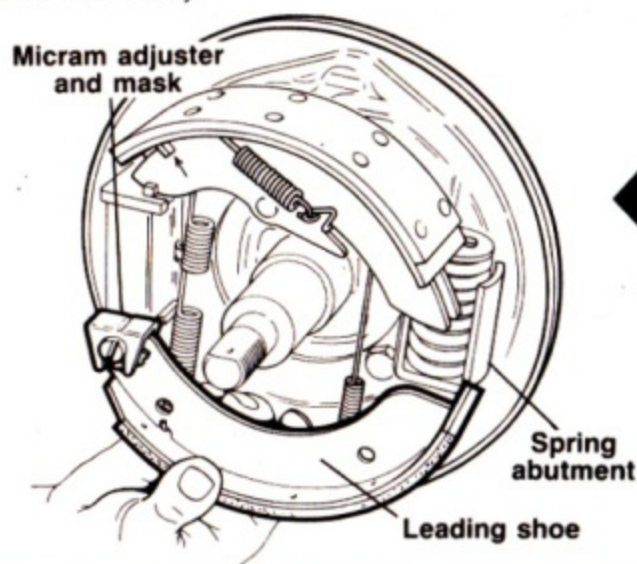
4

Lift the leading shoe from the spring abutment and slide the adjuster and mask off the expander body. Remove both shoes from the backplate.

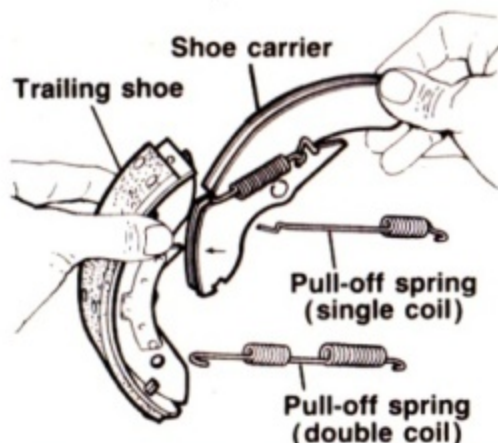
5

Slide the carrier assembly from the trailing shoe to expose both pull-off springs. **Note their positions and remove them.** The double coil spring is not interchangeable with the one on the opposite brake.

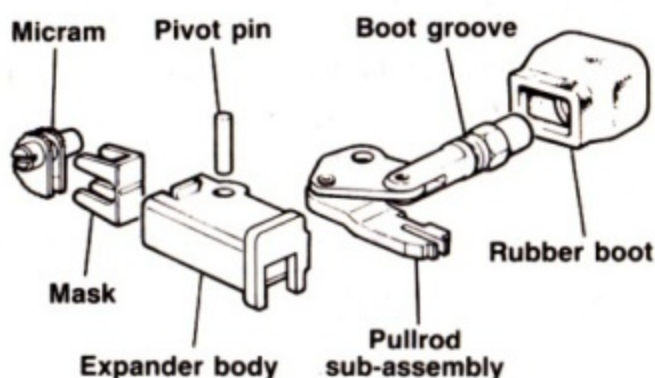
Lubricate the pullrod sub-assembly with **Lockheed Expander Lubricant (Part No. LPK 103)**, fit into the expander body and insert the pivot pin. Fit the expander assembly onto the backplate and check that it slides freely in the slot. Pack the rubber boot with **Lockheed Rubberlube (Part No. LPK 102)**, and slide over the pullrod up to the backplate. Ensure that the boot lips locate correctly over the backplate tabs, and also seat into the pullrod boot groove.

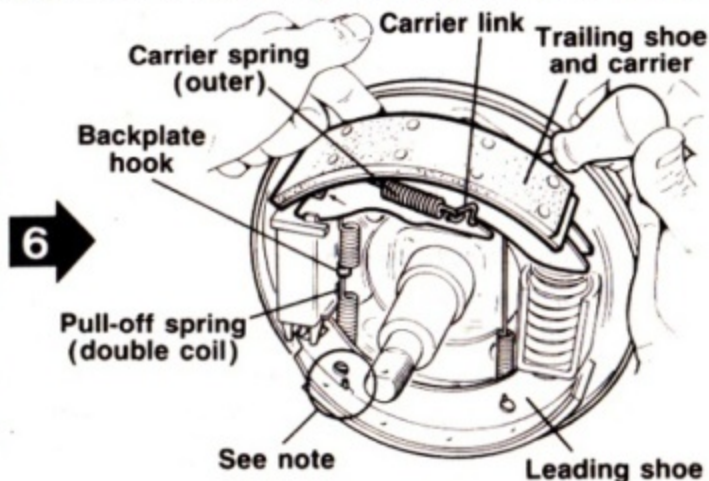
Assemble the new shoes, carrier and springs by reversing the removal procedure. Ensure the carrier link locates onto the spur on the trailing shoe web. Set micram to minimum adjustment. After shoe replacement ensure that the carrier springs are correctly located. The outer spring is easily seen, but the shoe and carrier should be eased away from the backplate so that the inner spring can be felt to confirm correct positioning.

Note — the pull-off spring hook (**double coil**) is located into the slotted hole adjacent to the leading shoe platform, also ensure that the spring is behind the hook on the backplate.

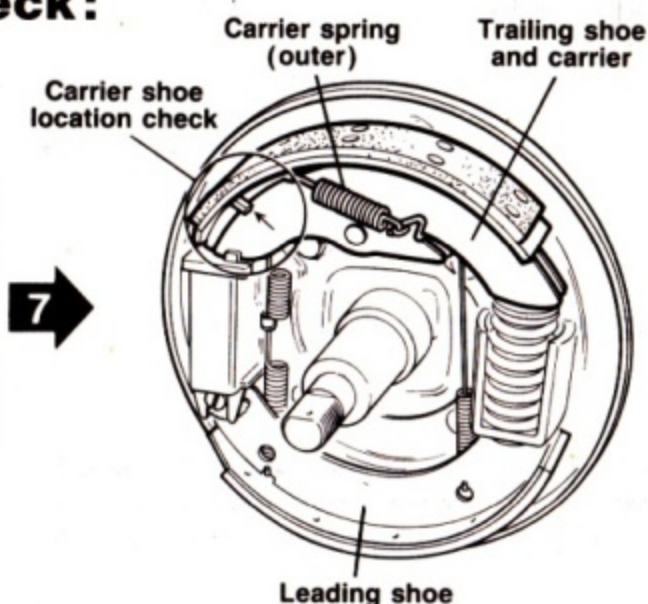
Near the heel on the trailing shoe web, will be seen a metal tab. Stamped into the carrier in this area is an arrow marking. The shoe is correctly located in the carrier when these two line up exactly. Check the shoe action in the carrier by pushing the shoe against the carrier springs, when released the shoe should freely spring back to the marked position. **The tab and arrow position must always be checked through the hole in the drum before brake adjustment is carried out.**

2. Check for correct shoe position in the carrier through the hole in the brake drum, ideally using a torch or inspection lamp. The arrow stamped on the carrier must align with the metal tab on the shoe platform.

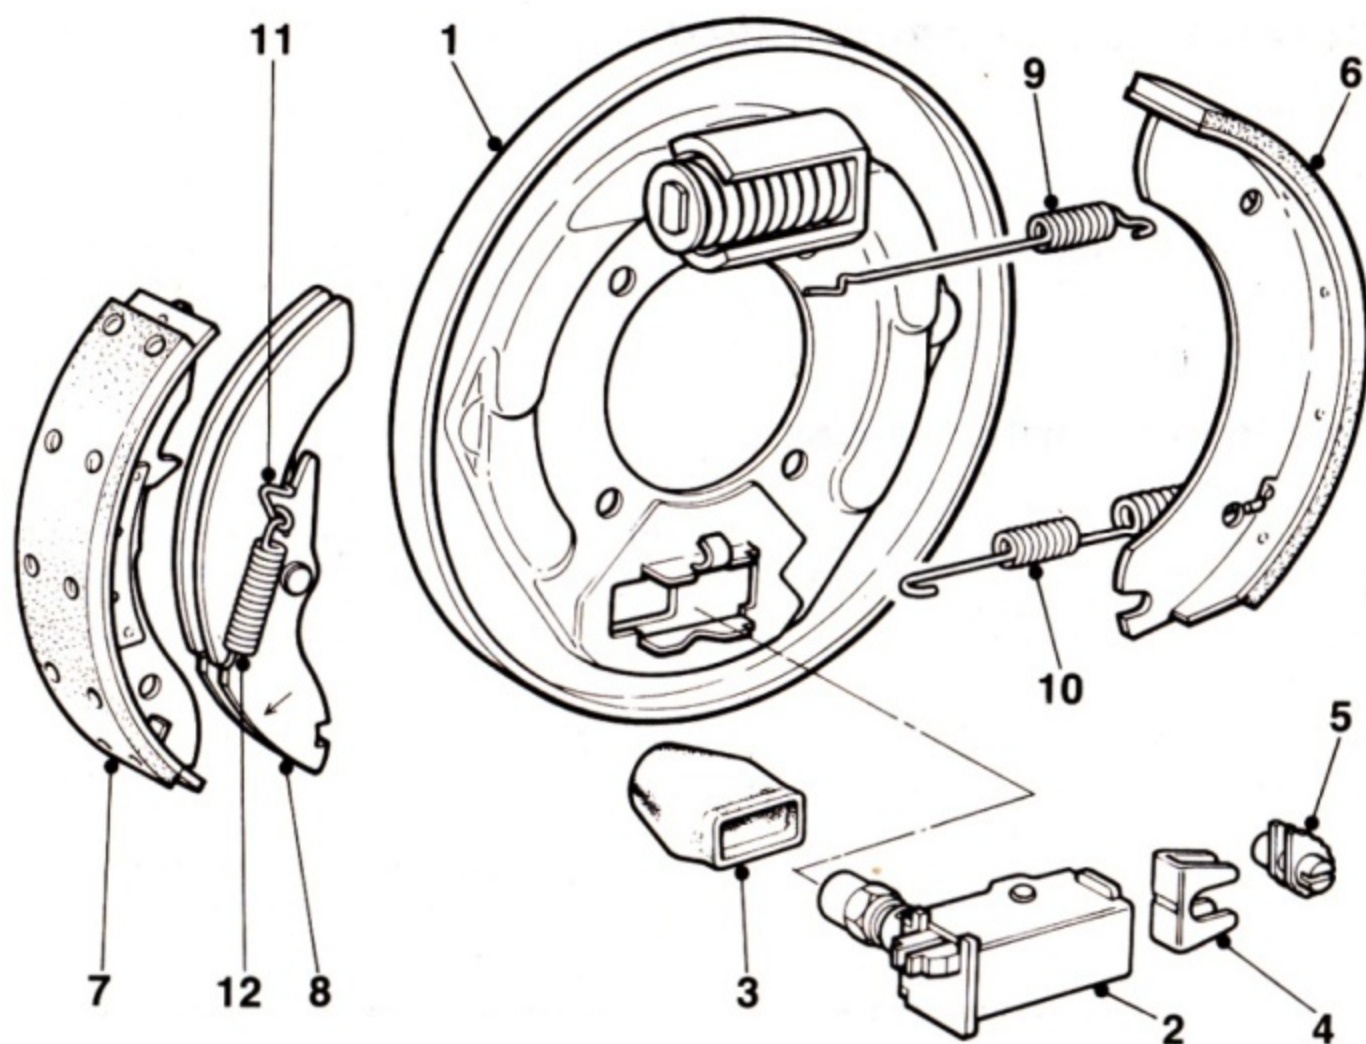
BRAKE ASSEMBLY COMPLETE

R.H. = LG 15050 L.H. = LG 15051

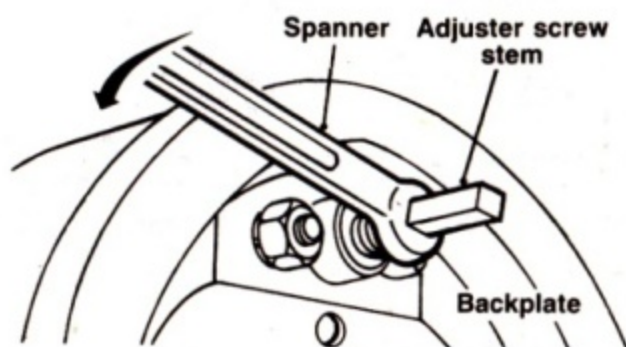
Fig. 1

With a suitable spanner back off all brake adjustment by turning the square adjuster screw stem behind the backplate fully anti-clockwise. **Fig. 1.**

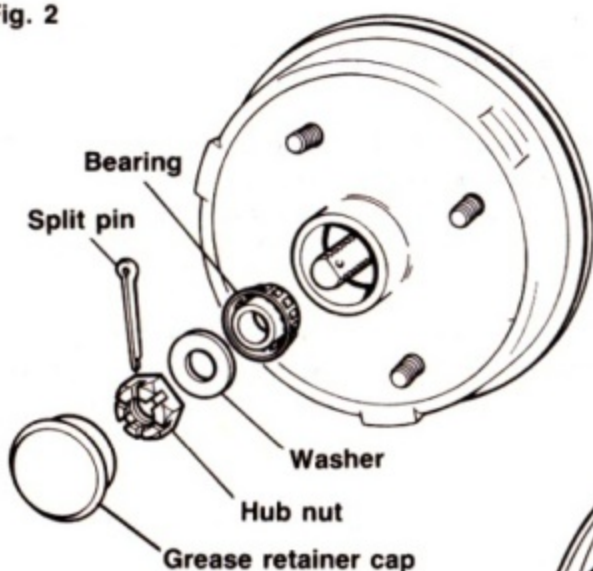
Fig. 2

Prise off the hub grease retainer cap and remove split pin, hub nut, washer and bearing. Withdraw the brake drum from the stub axle. **Fig. 2.**

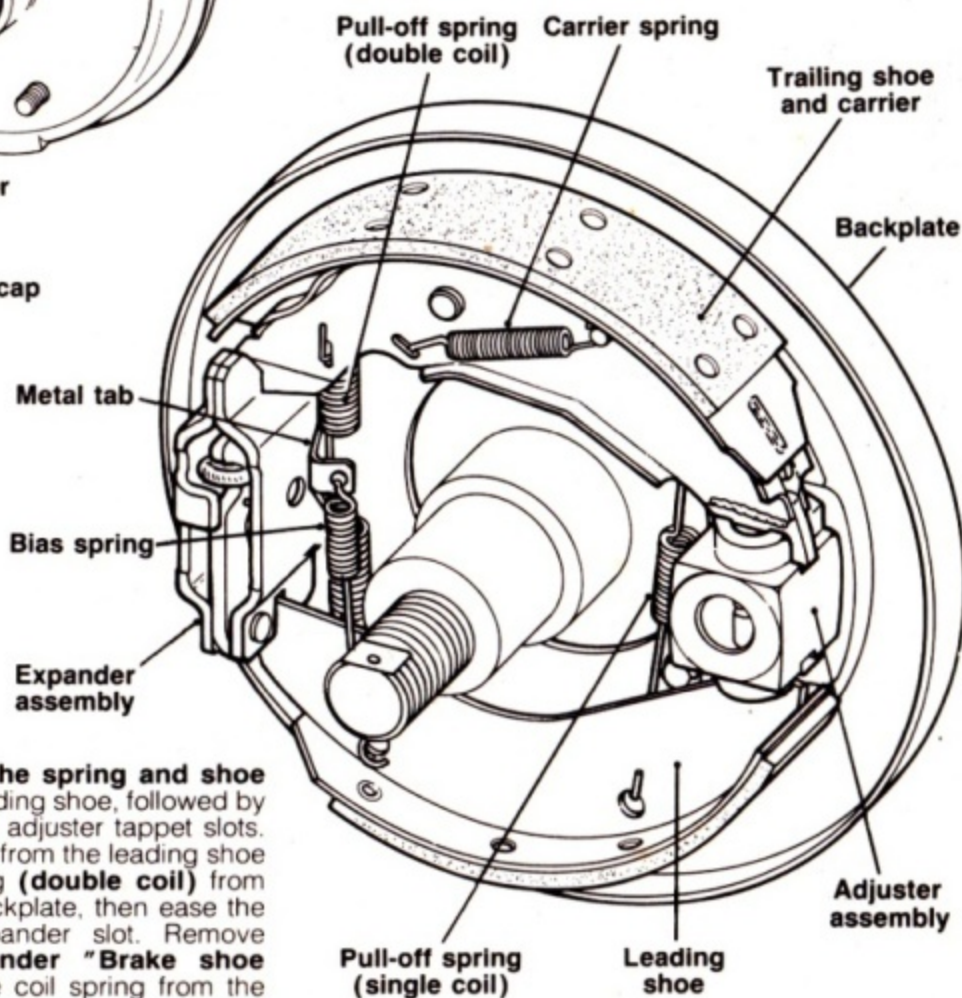
Fig. 3 L.H. brake assembly

After taking careful note of the spring and shoe positions pull the heel of the leading shoe, followed by the toe of the carrier, out of the adjuster tappet slots. Disconnect the single coil spring from the leading shoe web. Release the pull-off spring (**double coil**) from behind the metal tab on the backplate, then ease the leading shoe out of the expander slot. Remove bias spring, (**see note 5 under "Brake shoe replacement"**) and the double coil spring from the leading shoe web. Note the spring hook positions then remove from carrier. Disconnect both carrier springs and remove trailing shoe from the carrier.

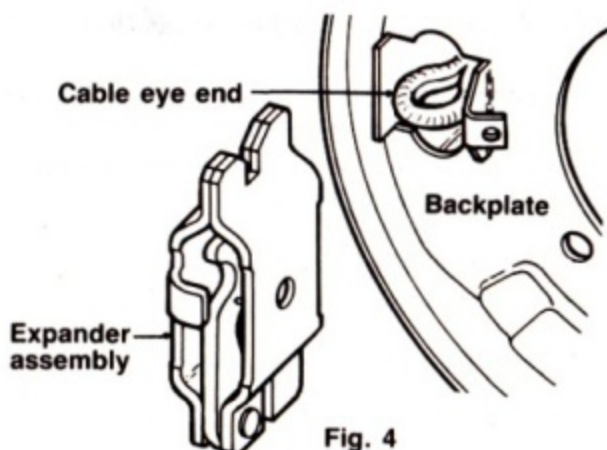
Fig. 4

Disconnect eye end of operating cable and remove expander from backplate. Remove all dust and deposits from the backplate (Fig. 4). **Do not blow out with an air line, it could be harmful to inhale the dust,** but remove with a vacuum cleaner or wipe clean with a damp cloth. **Do not use petrol or paraffin,** if a solvent is necessary methylated spirit should be used.

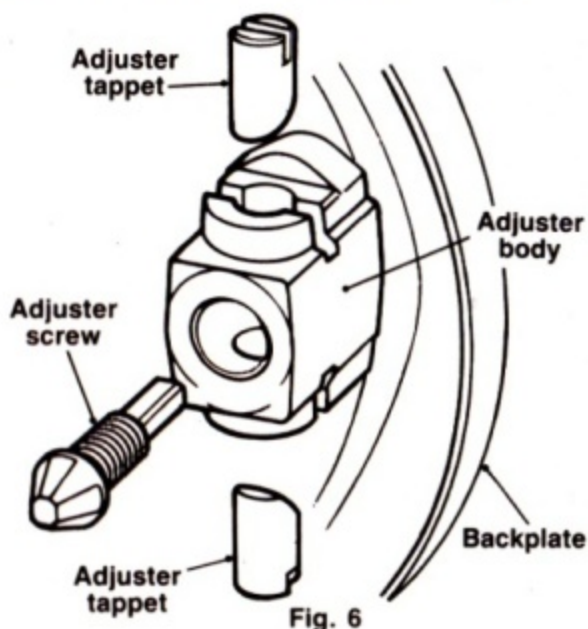
Fig. 6

Unless damaged the adjuster body need not be removed from the backplate. Extract adjuster tappets, unscrew and withdraw adjuster screw. Thoroughly clean the parts, then smear tappets and adjuster screw threads with **Lockheed Expander Lubricant**. Screw adjuster fully into place to provide minimum adjustment, ensure that the threads of the adjuster stem exposed behind the backplate are well coated with the lubricant. Insert the tappets into adjuster body, the sloping ends coincide with the tapered angle of the adjuster screw. Fig. 6.

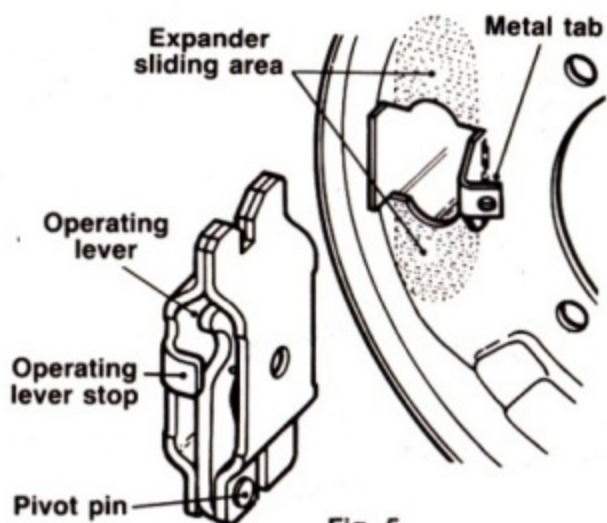
Fig. 5

Lubricate the expander operating lever and pivot pin with **Lockheed Expander Lubricant (Part No. LPK 103)**, also smear onto the area of the backplate on which the expander slides (Fig. 5). Fit the expander against the backplate, it is particularly important to check that the brake shoes are fitted the correct way round. With the L.H. brake assembly (as illustrated) the expander operating lever stop faces towards the adjuster assembly. On the R.H. brake assembly it faces away from the adjuster, then the shoes are fitted accordingly.

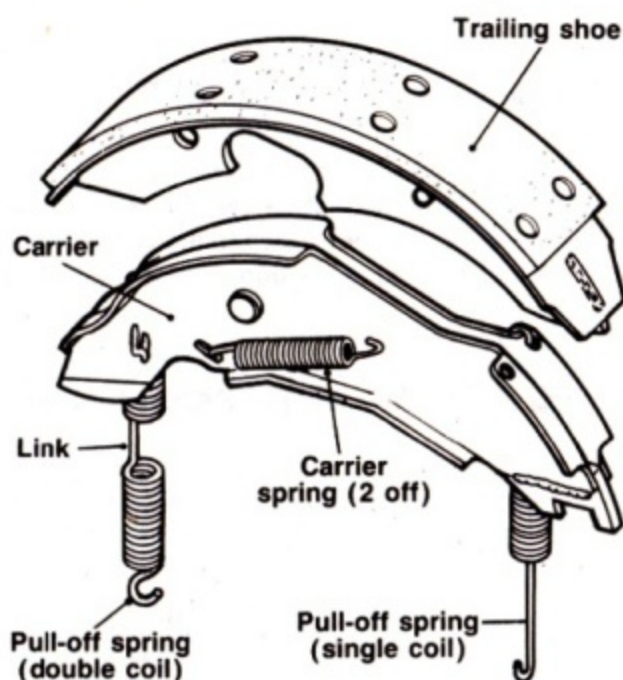
Fig. 7

1. It is important that the brake shoes are fitted the correct way round with the L.H. brake assembly (**as illustrated**) the operating lever stop faces towards the adjuster. On the R.H. brake assembly it faces away from the adjuster, then the shoes are fitted accordingly.

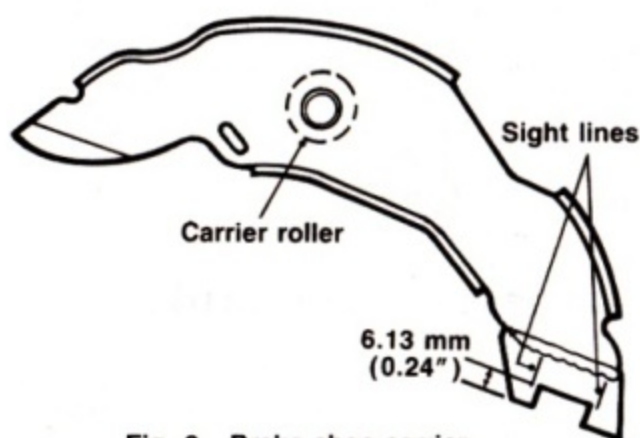
Fig. 8 Brake shoe carrier

Two types of shoe carrier design have been used with this brake assembly. The latest design has an increased adjuster location recess depth of **6.13 mm (0.24")** as illustrated. It is important that the new carrier is only used with the latest type adjuster assembly that has deeper body slots to accommodate the new carrier shape. The new adjuster assembly if required is available under (**Part No. 4158-133**), and can be identified by the (**body casting no. 3144-310 C**).

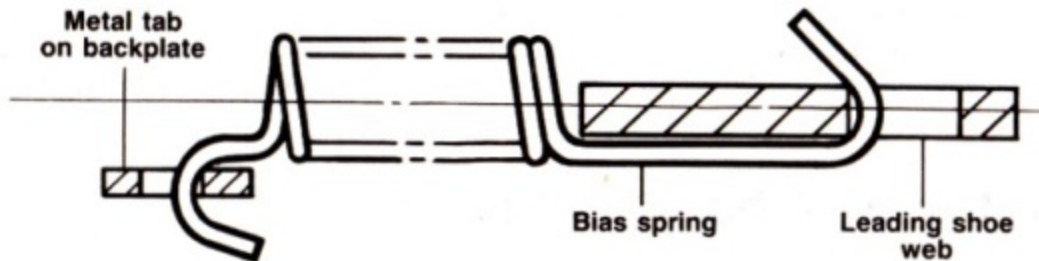
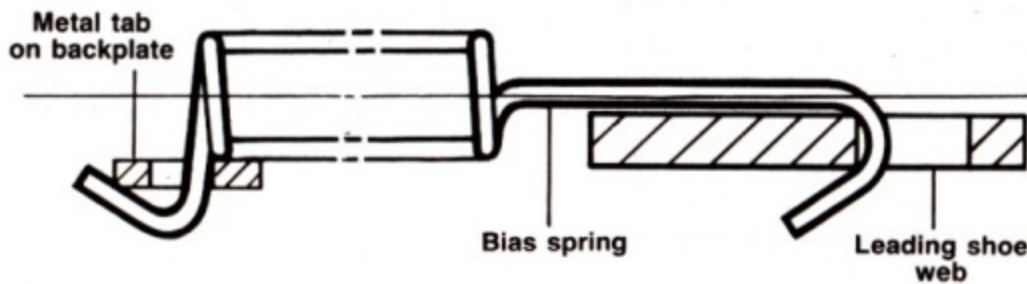
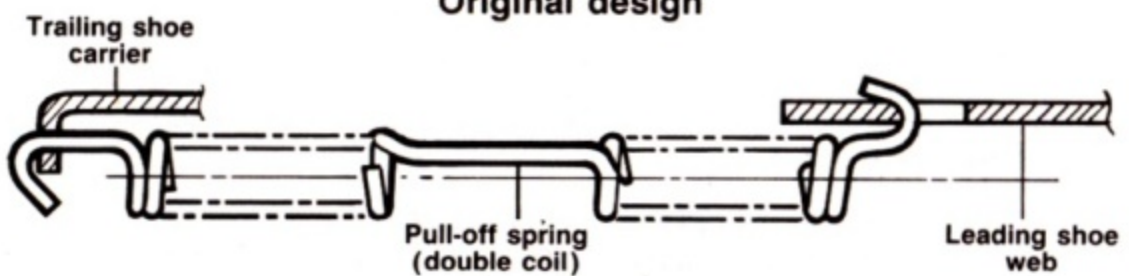
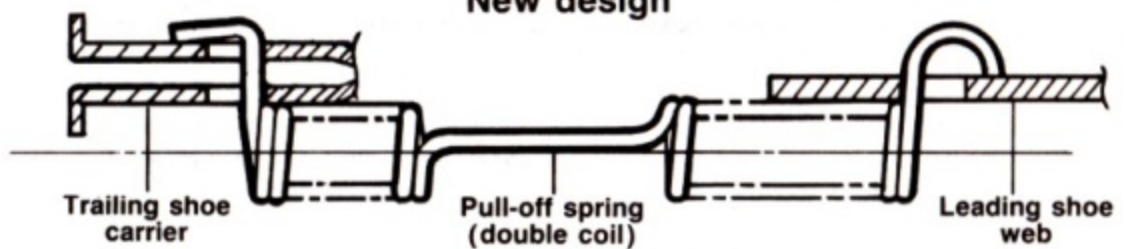
Fig. 9

Location of new design bias spring

Original design

New design

Location of new design pull-off spring

A new design of double coiled pull-off spring and a new design bias spring are incorporated in Spring kit **LK 17056**. For details of their correct location refer to **Fig. 9** on page 12 of this manual.

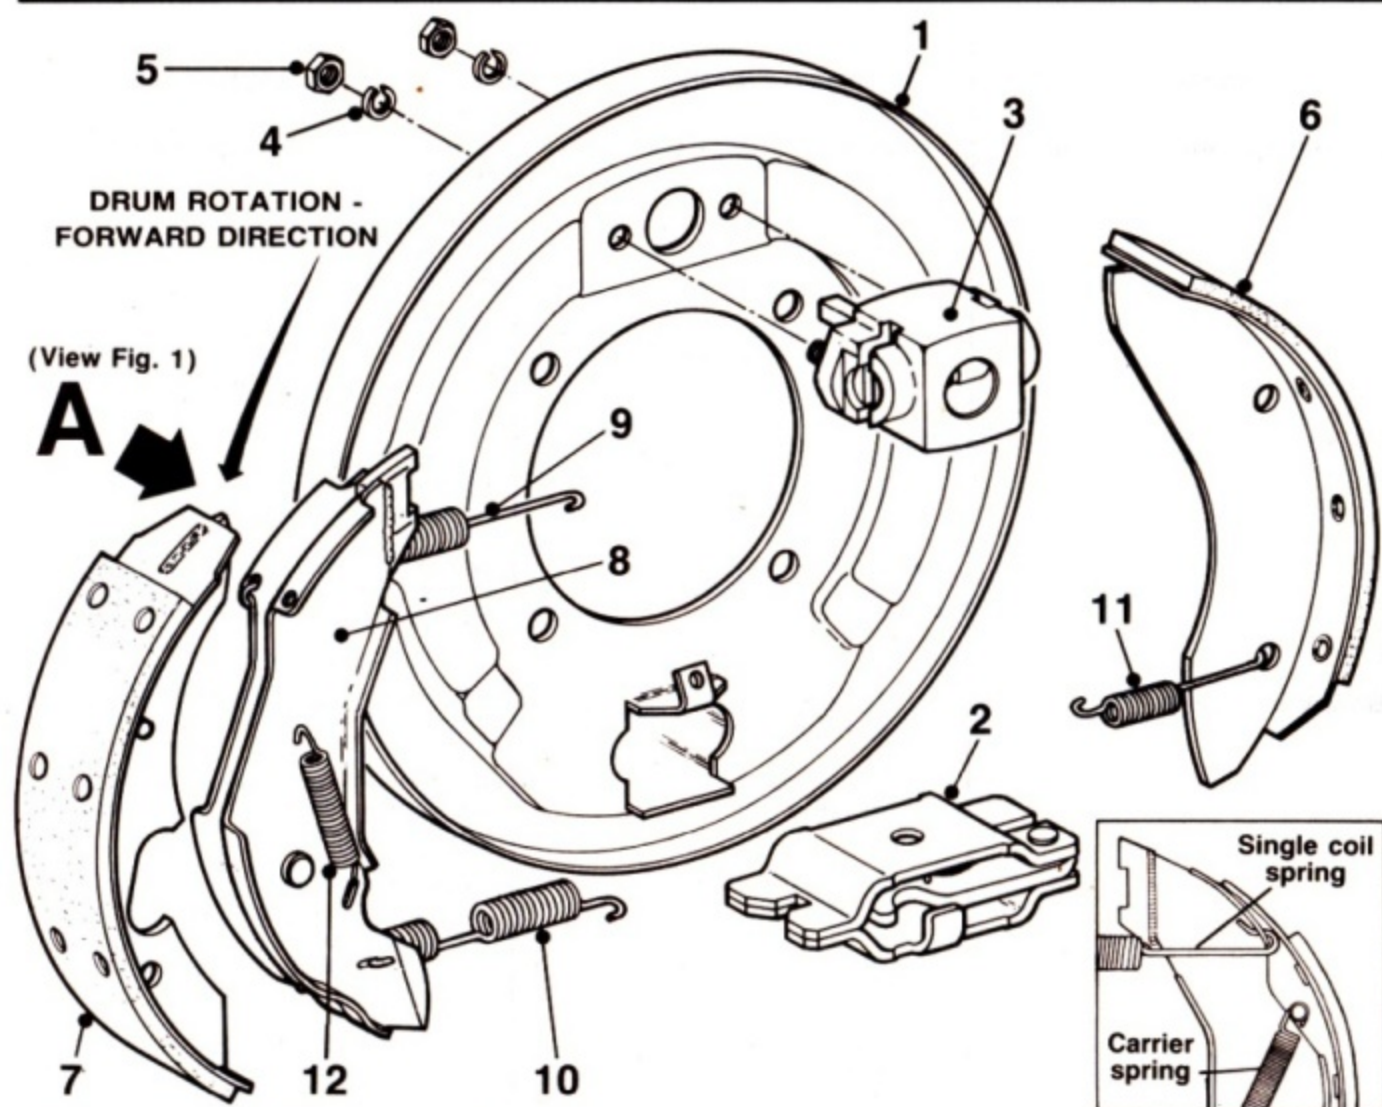
Fig. 1

BRAKE ASSEMBLY COMPLETE

R.H. = LG 15048 L.H. = LG 15049

L.H. BRAKE ASSEMBLY

4. Check that the single coil pull-off spring is hooked into the carrier correctly as shown in **Fig. 1 on exploded assembly**, which is a view from direction of **arrow 'A'** with the brake shoe assembled to the carrier.

5. Certain chassis manufacturers fit the brake with the leading shoe in the top position. In this case the bias spring (4) is unnecessary and is not fitted.
