## **'Rusty's Renovation'**

Having looked for our first Caravan, to accommodate 2 kids, 2 Adults, toys, bikes, roller skates, scooters etc., we were confused about what to buy, and how much to spend. Until we came across 'Rusty'. A 1988 Compass Rallye 510 5 Berth. He was sitting in our friends front drive ready to be sold in the local paper. Giving it a quick look over we knew there was work to do on it, but it was the one ... ( little did I know how much work) !!.

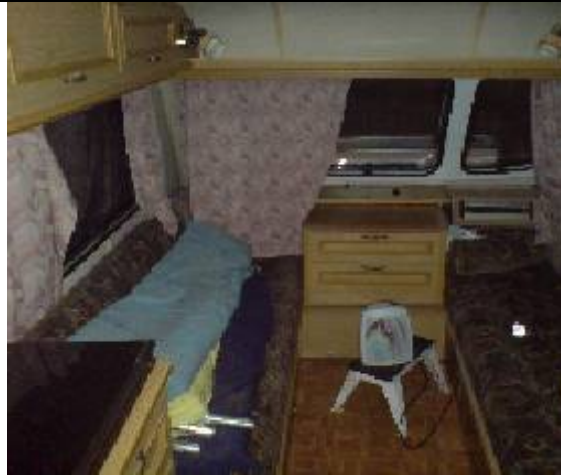
Bit of a mess

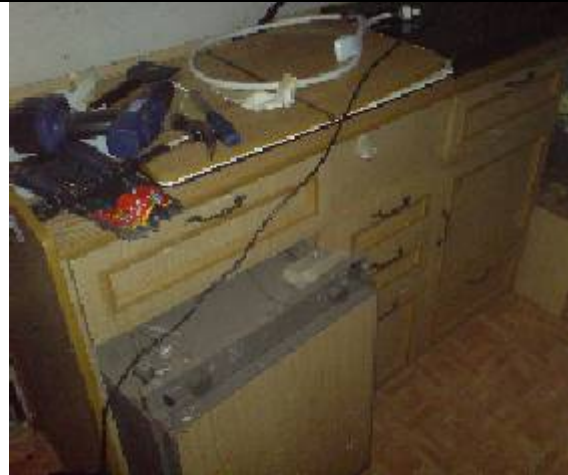
The fridge had got to there following the tow home!

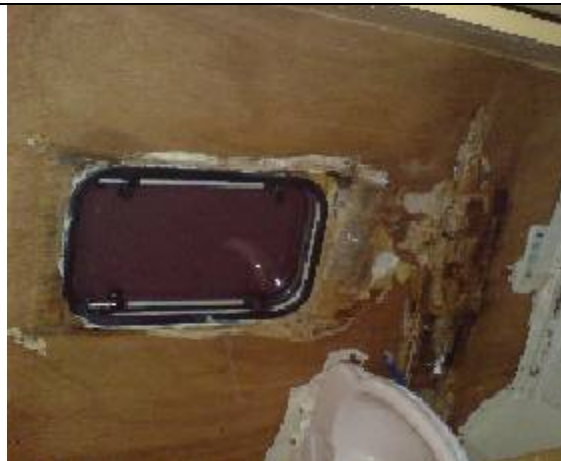
The extent of the damp in the bathroom

First job was to get the bathroom window sorted, which involved a complete strip back to the aluminium skin (carefully) removing the boarding and the insulation. This revealed a large amount of water had been coming in from the rails on the outside (another job loomed). Once the rails had been replaced with new mastic and screws, over a couple of weeks I checked there was no water coming in, then used Unibond to stick new battening where the old rotten wood once was. Then it was a case of plywood shaped to fit the 'hole' and new wallpaper, a daunting job that was surprisingly straightforward as I took my time.(and rested between stages).

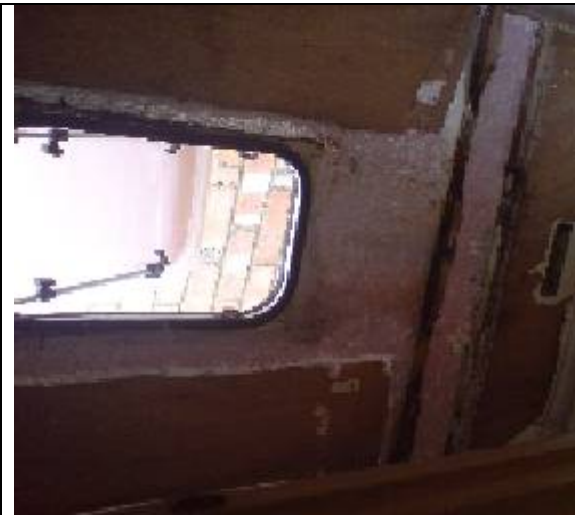
Stripped back to the outer skin.

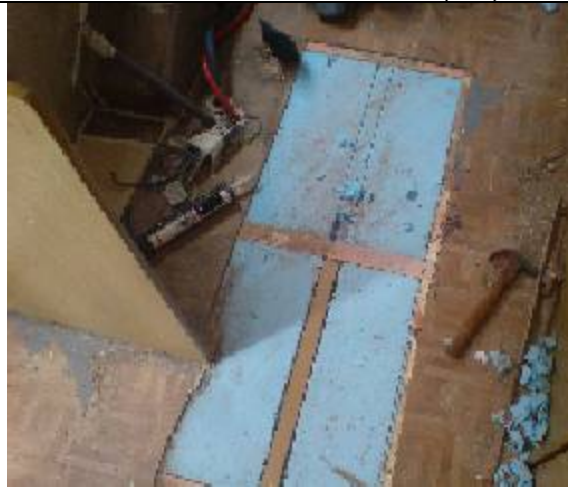
I'd spent many hours looking into 'delamination' before revealing the full extent of the damage to the floor areas under the leaking skylight. Once I lifted the tiles I realised a rotting floor is what I had. So it was similar to the bathroom, strip the rotten and replace..

You can see the insulation under the rotten ply. I'm adding further support prior to adding the new ply on top.

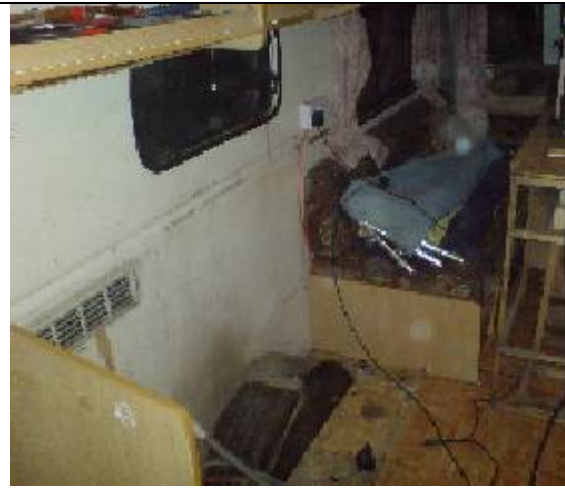
Next - this nasty looking mess where the wheel arch had blown out....

There had been a previous 'blow out' which forced the wheel arch cover to be ripped off under the kitchen unit. This caused all sorts of damage and ripped out the cables for the taps and fridge. It took a while to remove the unit but once I found all the screws I was able to move it out of the way. Rather than unbolt the wheel arch cover from between the floor and chassis. I decided to cover the exposed tyre using exterior marine grade ply. Once this was glued, screwed and sealed it formed a neat cover to replace the kitchen unit back over. While I was at it, I recovered the kitchen drawers and cupboards with Fablon.

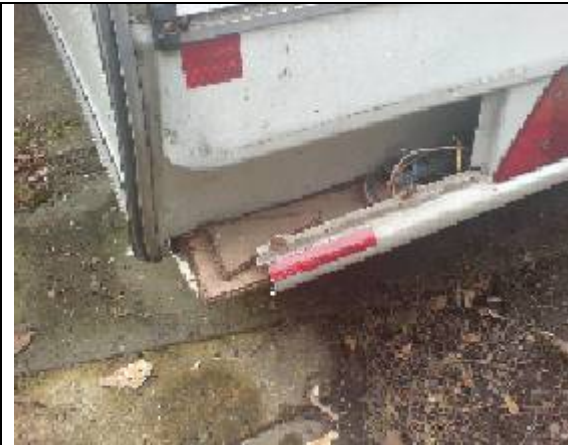
**While working on the inside, I'd noticed that the rear lower panel, that houses the rear lights and number plate had been 'taped up'. I decided (wish I hadn't) to have a little look underneath. Here's what I found.**

Both corners were like this, and the light clusters smashed beyond repair. Off to Halfords for some P38 compound and wire mesh body repair kits.
