Ray's caravan Repair

ABI Marauder 520 ET

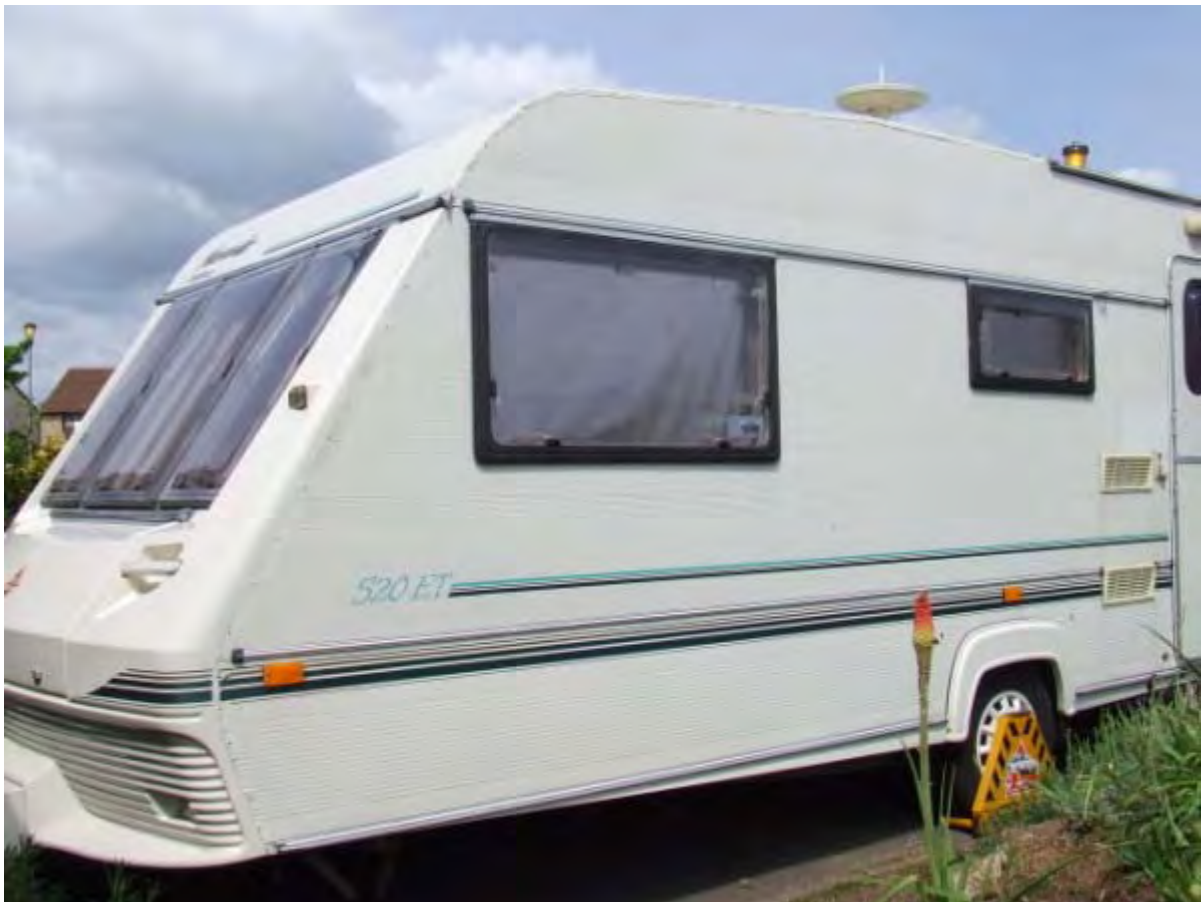
Nice and clean?

CLEAN AND DRY

Using 'Seamseal', the gaps and uncovered areas were sealed, the lumpy bits flattened down and the caravan was now better than it was when first bodged in manufacture.
