The right input

Matt Stubbs concludes installation of a new mains electrical system in our old Sprite project caravan, fitting an appropriate inlet socket

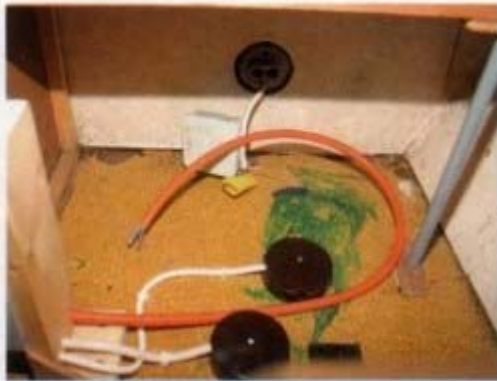
1 I had connected the consumer unit to two junction boxes, one cable being rated at 10 amp capacity and the other 6 amp. I intend to use the 10 amp for the mains sockets and 6 amp for lights and fridge

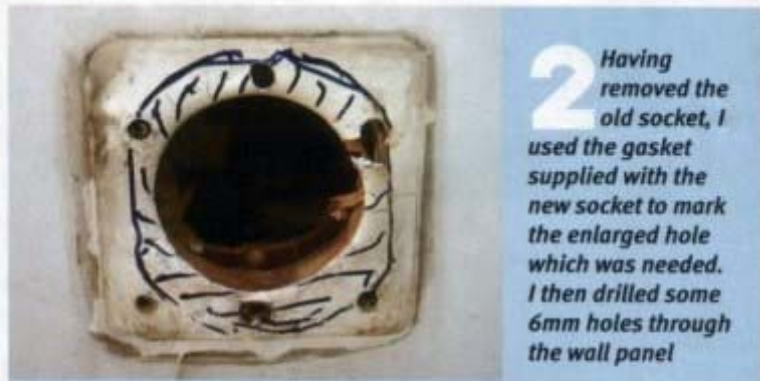
2 Having removed the old socket, I used the gasket supplied with the new socket to mark the enlarged hole which was needed. I then drilled some 6mm holes through the wall panel

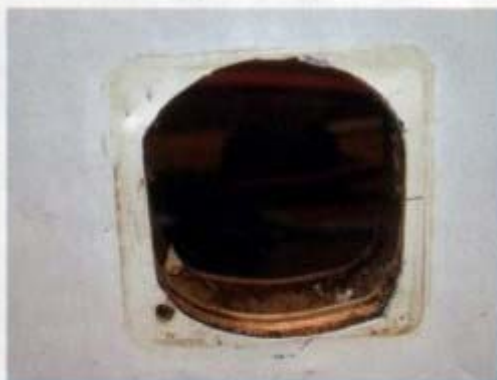
3 The old rule 'cut undersize and open the hole up' applied here. Having cut the hole undersize, I used my power file gradually to remove material until the socket fitted

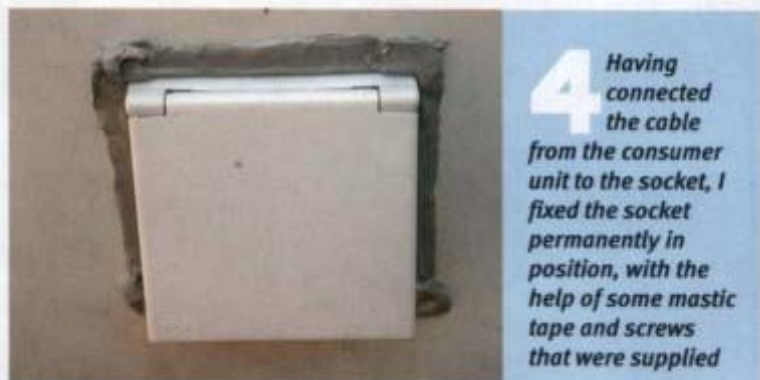
4 Having connected the cable from the consumer unit to the socket, I fixed the socket permanently in position, with the help of some mastic tape and screws that were supplied

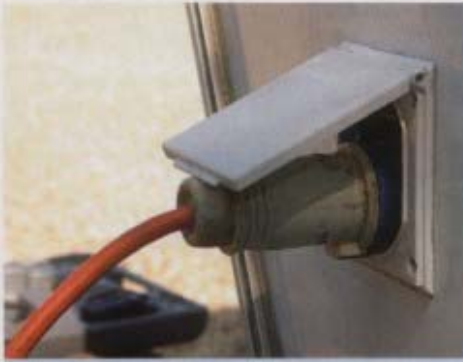
5 Before testing the system, I went under the caravan and made sure that the earth connection to the caravan's chassis was sound. Then I connected to the site mains

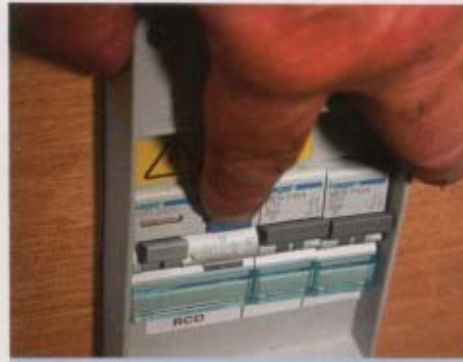
6 Once I had connected to the site mains, the next job was to test the trip on the RCD unit. As soon as I pressed the test button the unit tripped out, cutting power, so all was fine

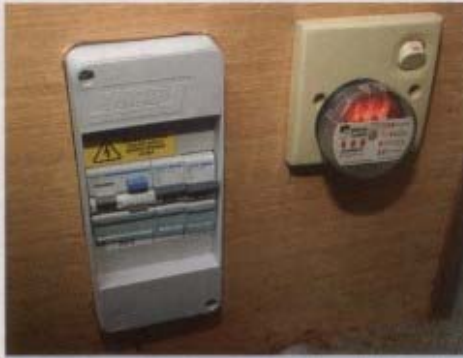
7 Having confirmed that the consumer unit was functioning properly, I checked that the 13 amp socket I had installed was wired properly, using my plug-in mains tester

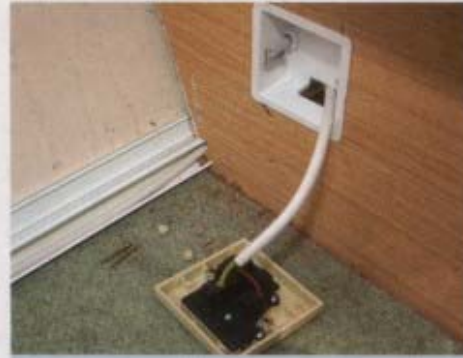
8 Having removed a continental-type socket here, I fitted a new mains socket. I ran cable round the van using some plastic ducting to protect it, seen on the left of the picture

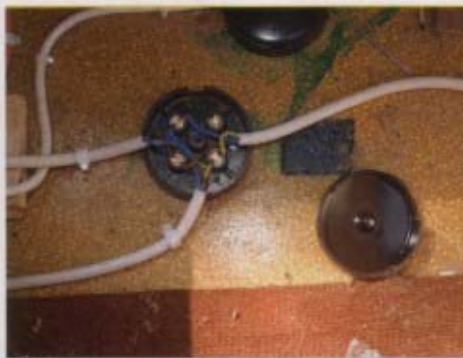
9 In the front nearside seat I connected the cable to the 10 amp junction box: brown (live) to brown; blue (neutral) to blue; and green/yellow (earth) to green/yellow

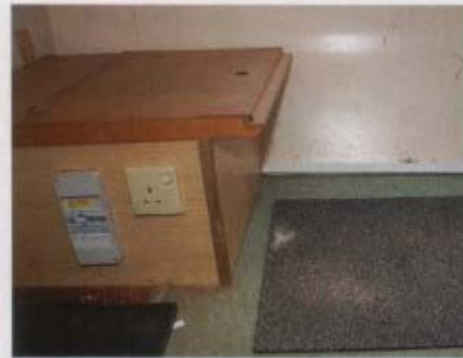
10 After connecting the junction box, I reconnected the mains and used my mains tester to check that the whole system was fine. I think the installation looks very neat

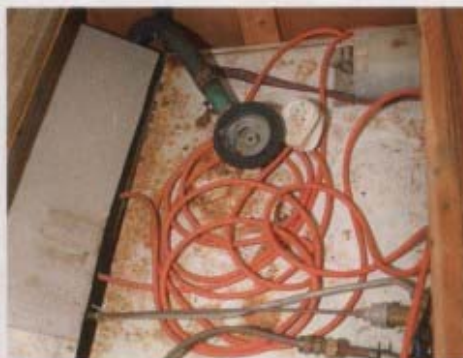
11 The final job was to remove the sink and drainer, and the hob and grill unit, which will eventually be replaced. I found this cable which was the old supply to the fridge

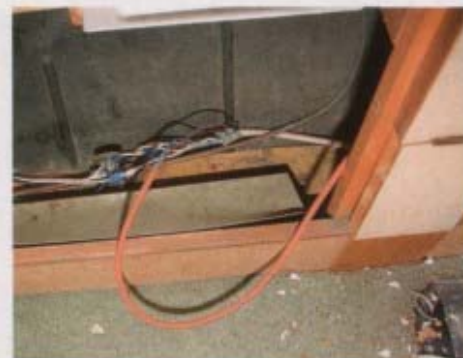
12 You can get some idea of the standard of wiring in the van from the state of the cables in the base of the kitchen unit. All were very light capacity and poorly connected
