1964 Glendale suspension Overhaul. Early Rubery Owen Chassis suspension repair.

Graham Collins modified the suspension on 'Little Eva' recently as a torsion bar broke 3 of its 5 leaves and it dawned on him that if the other 2 had broken the wheel and radius arm would have come off.

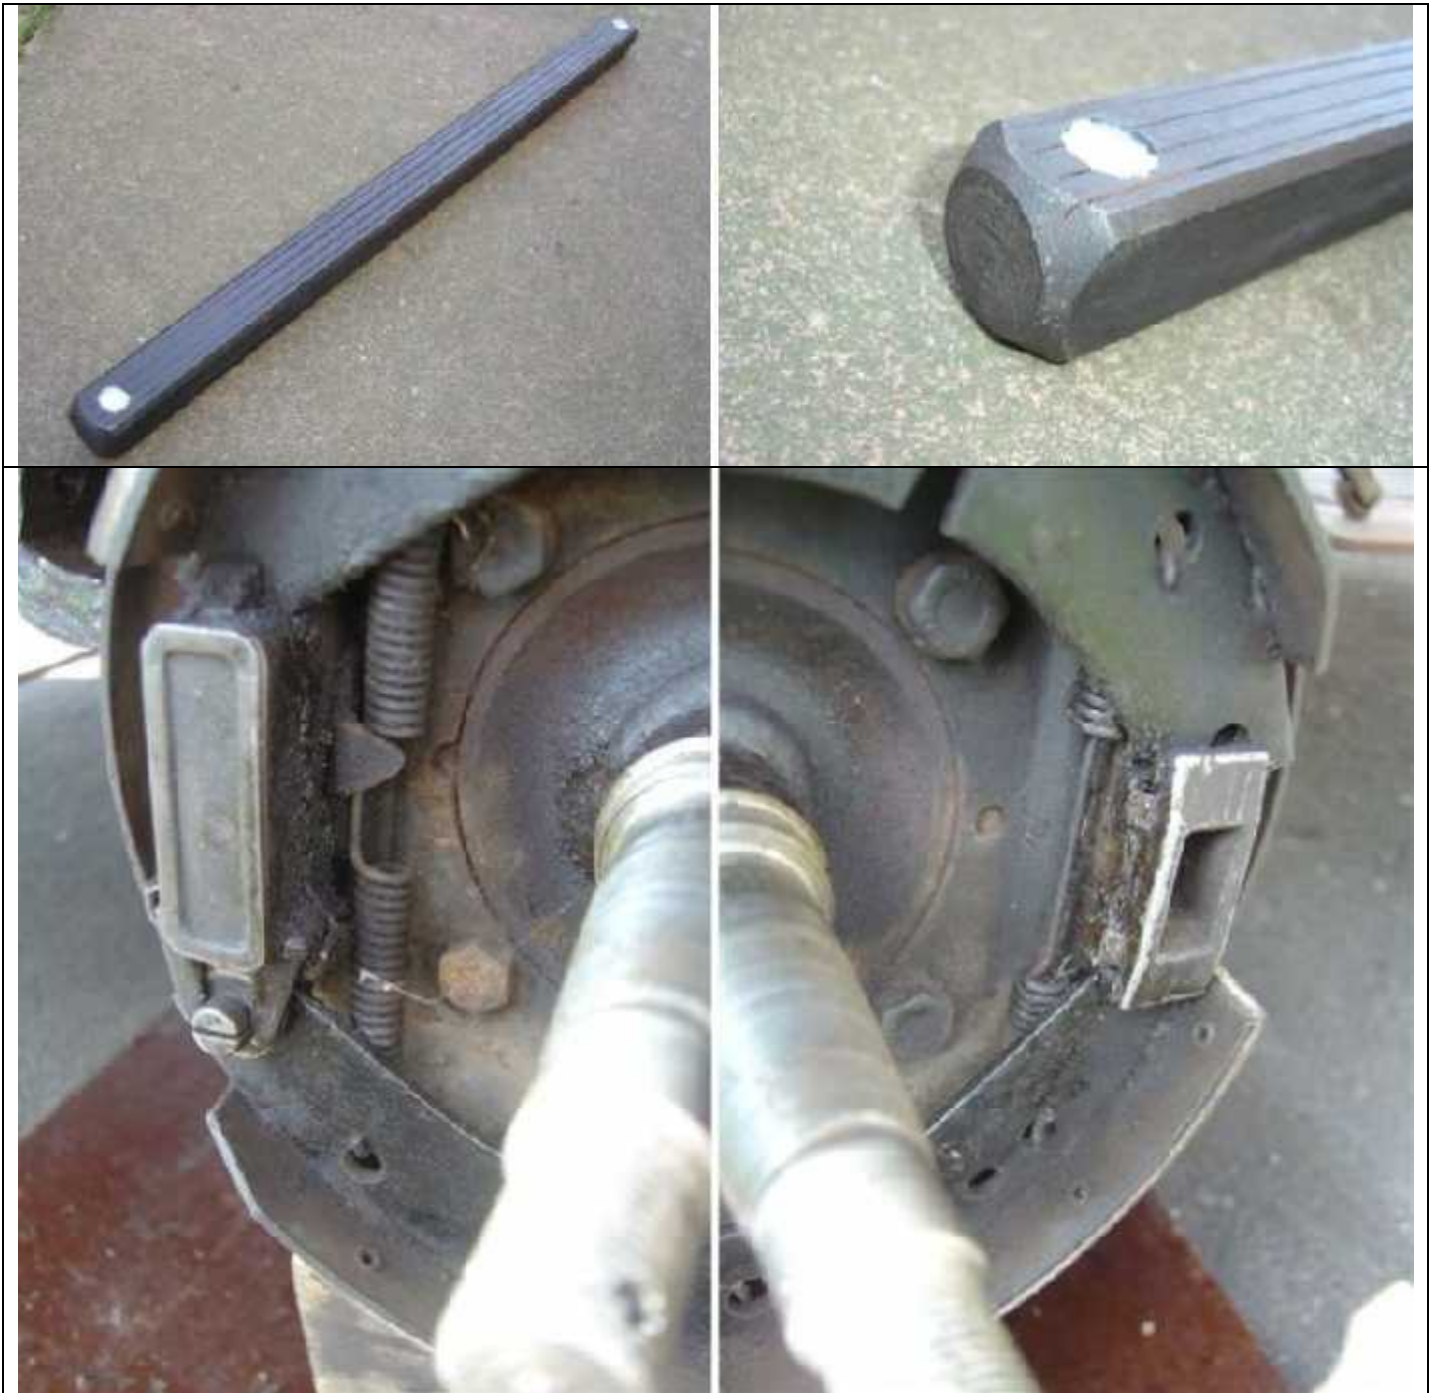
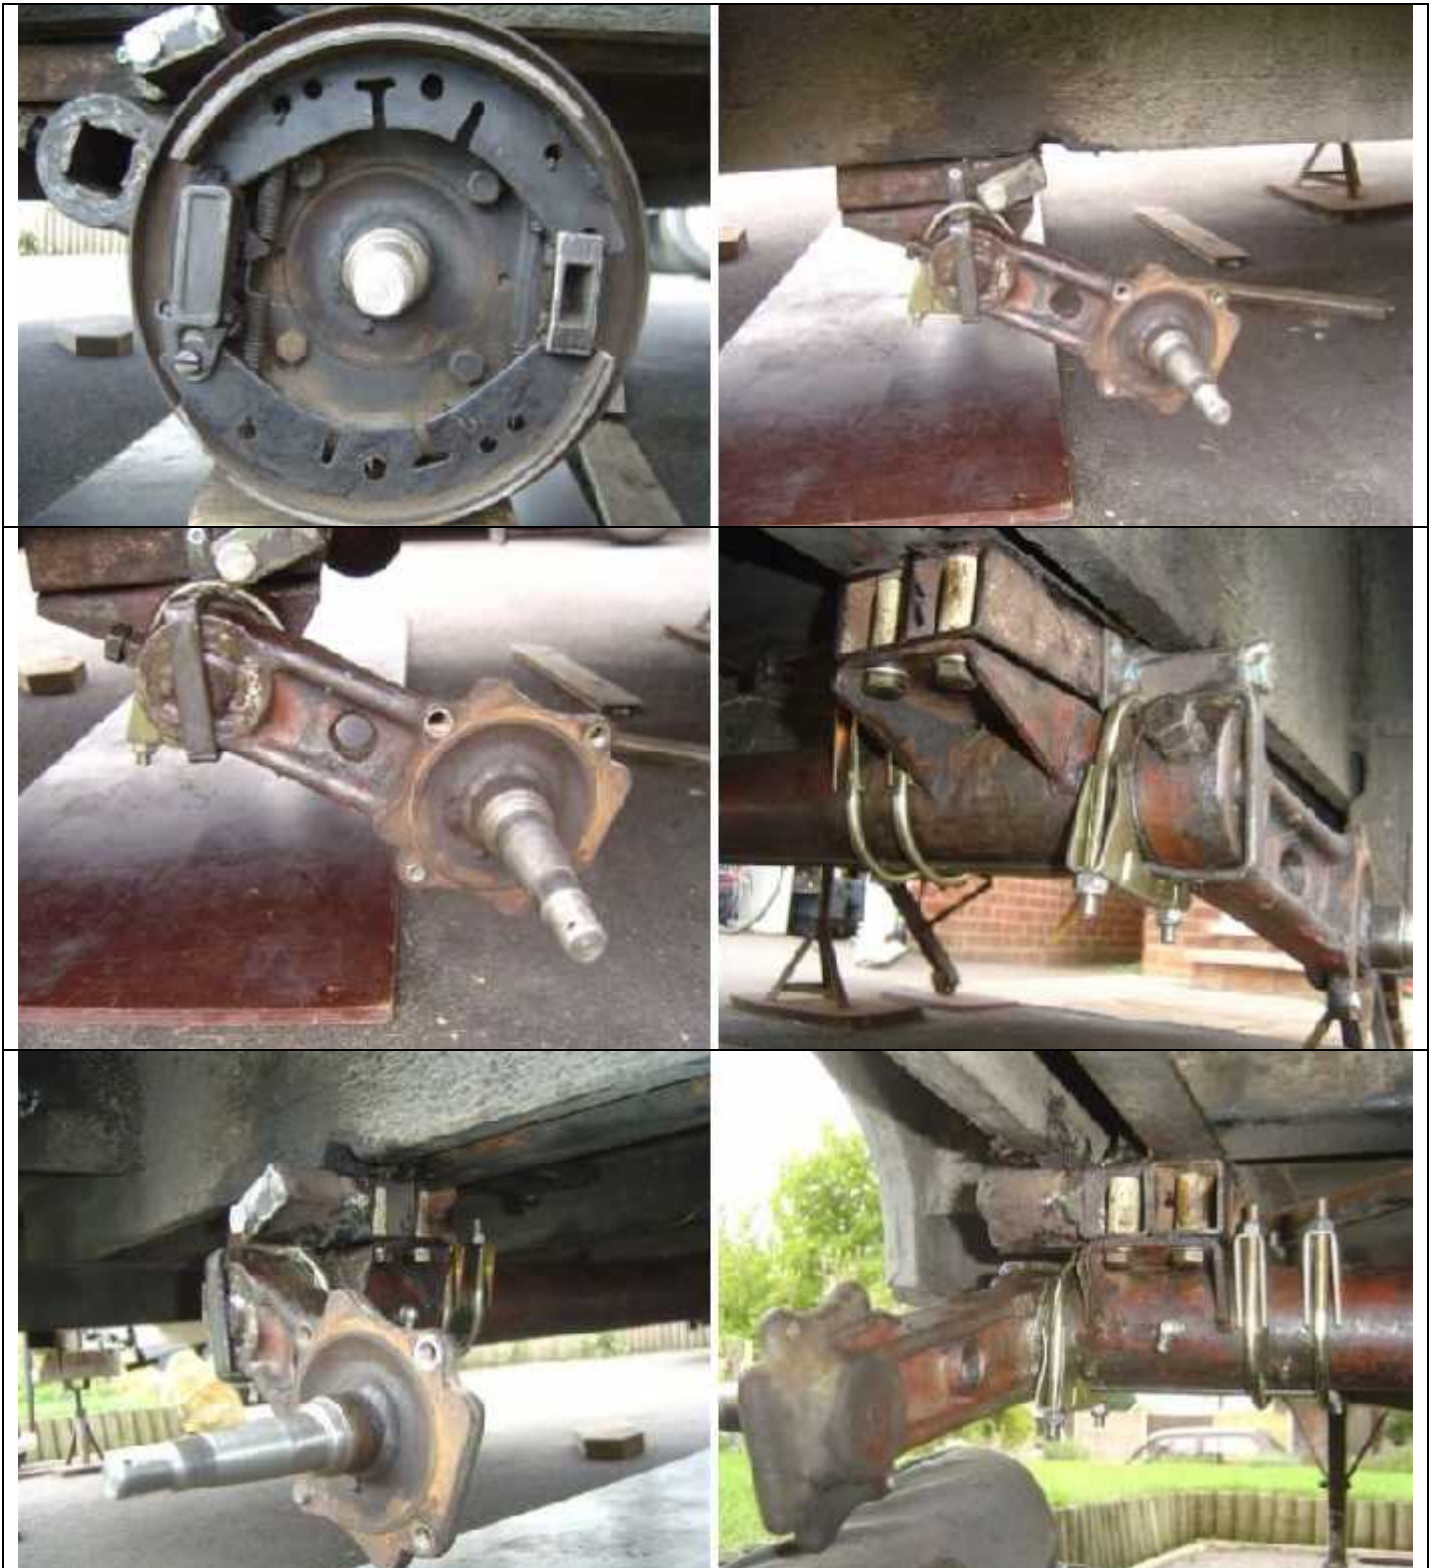
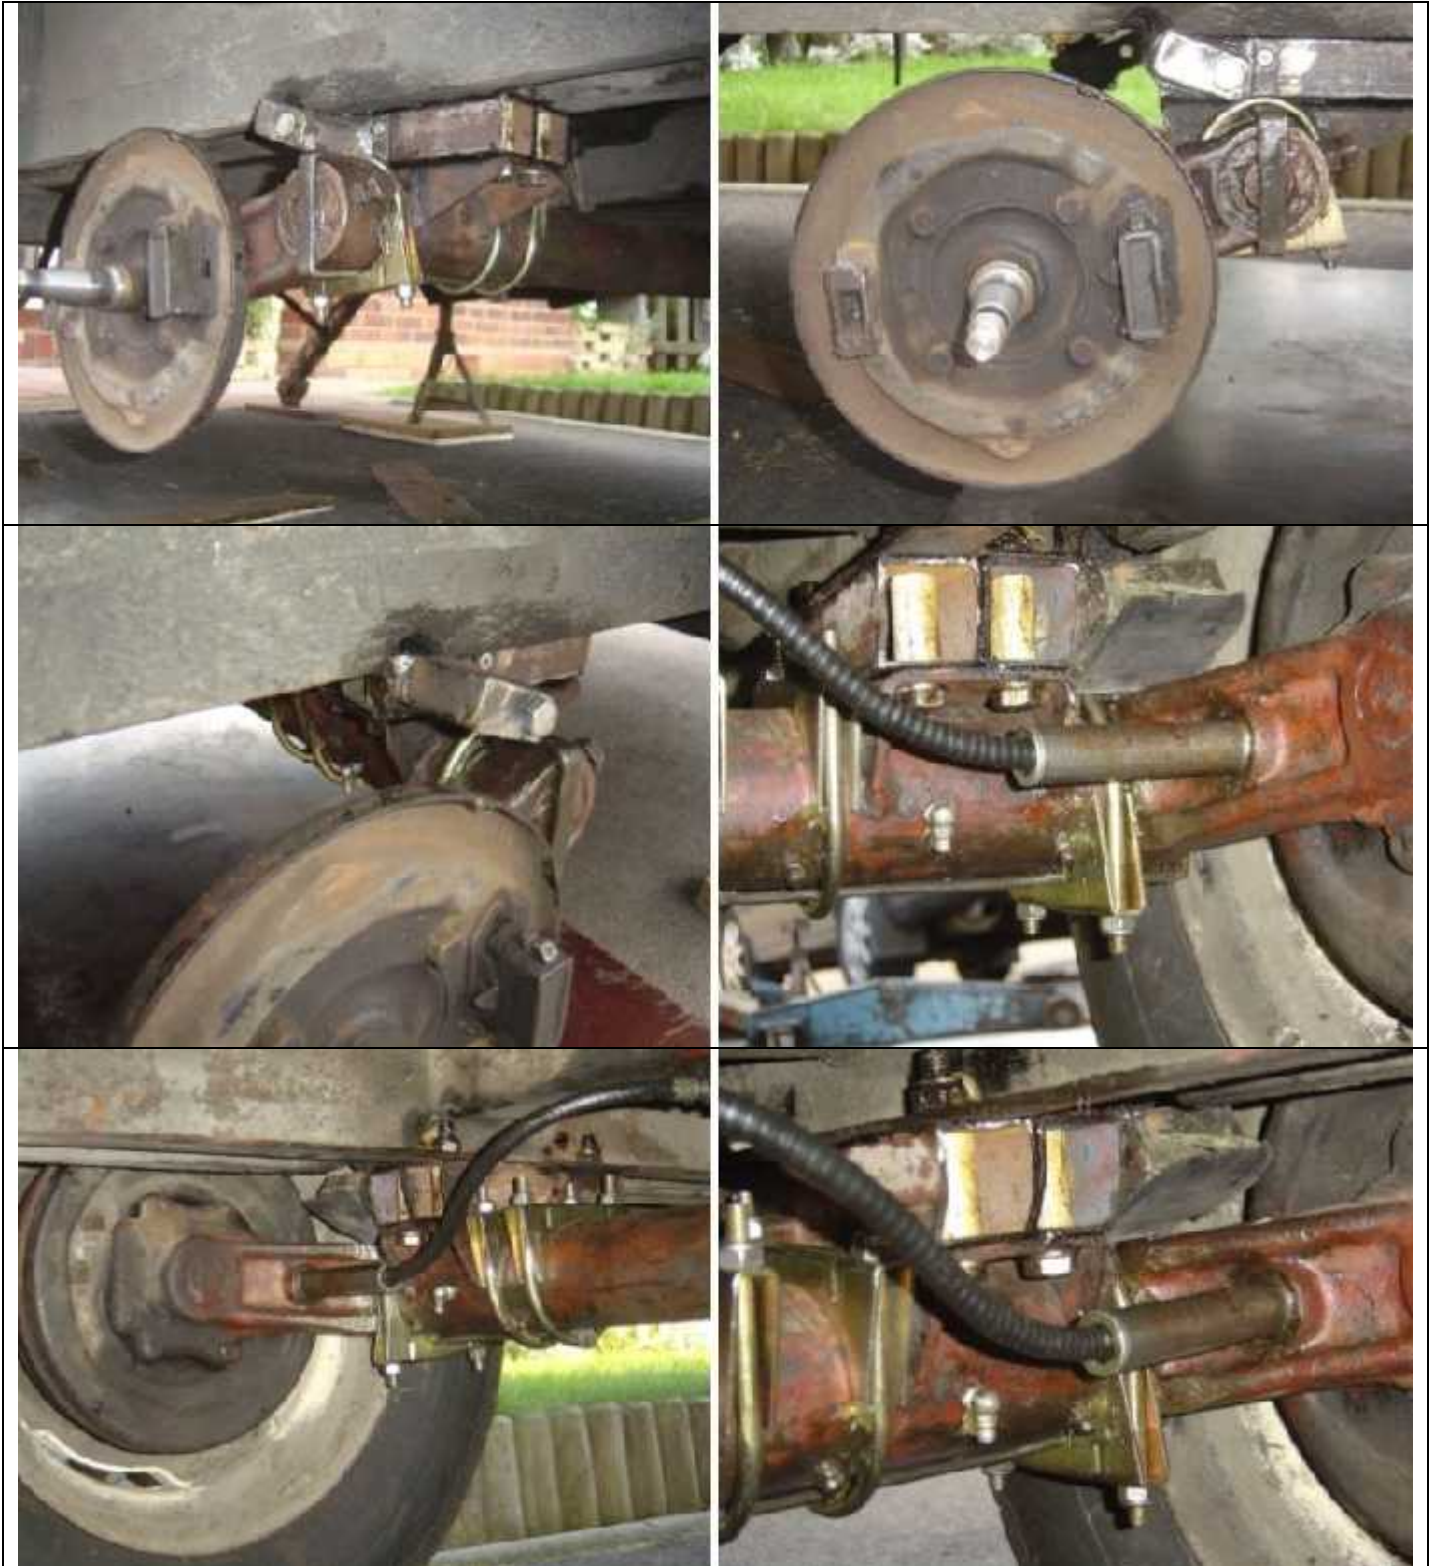
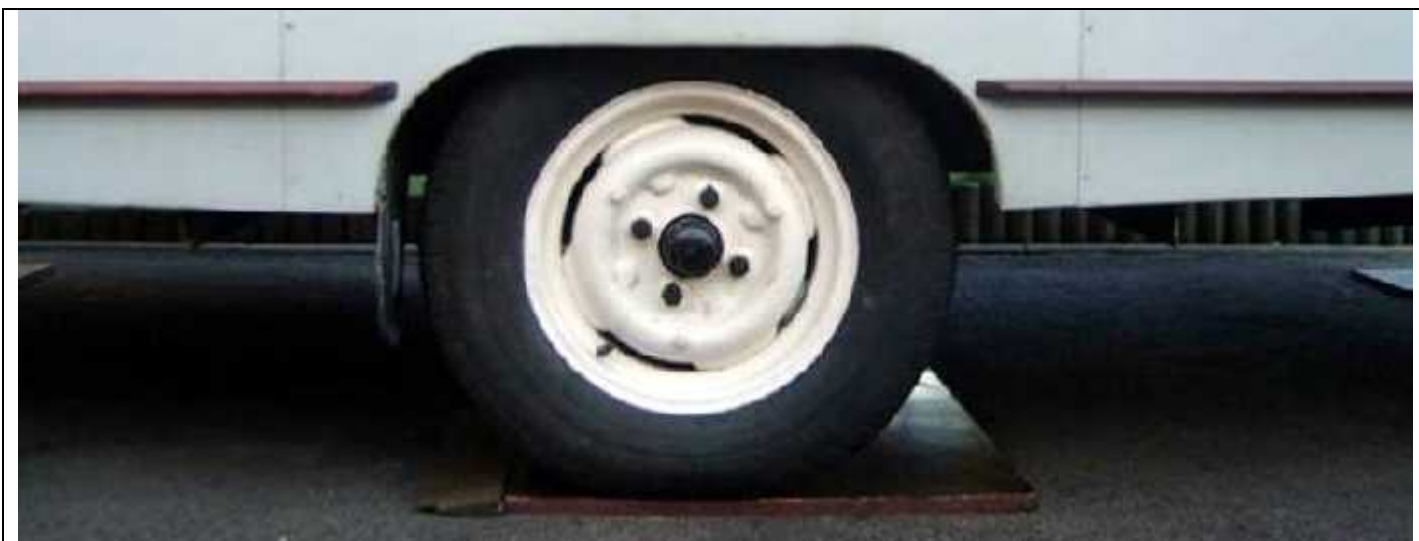
Here is his description of the work involved followed by pictures taken during the modification.

Basically I made up a spacer (2 square tubes on each side) to mount it on.

Then I welded a stop at an angle so the wheel can't hit the underside of the wheel arch/box to this 'spacer' should the torsion bar break.

This I welded inside and out with a long bolt as well to locate it first, then closing off the box with a welded plate.

Next is hard to describe but I made a brace which goes round the end of the torsion bar stopping the radius arm from travelling out.

This device is simply a piece of 1/2" x 1/8" strip bent and retained by 3 large 'D' clamps to the torsion bar tube.

I replaced the PTFE bushes which my Dad had the foresight to have as spares and added extra grease nipples between them.

They were ok but as I said the spacer has helped by raising the body, I wrapped them in Densel Tape plastered in grease.

The upward travel is now less than original (but plenty) so the bars will not be subjected to so much twist.
